Lead-Based Paint Testing and Lead Hazard Risk Assessment Report

PERFORMED AT:
3 Caledonia Ave
Quincy, MA 02169

PREPARED BY:
Titan Lead Testing, LLC
MA License # MI/R 4025
Expires 04/26/2024
PO Box 760709
Melrose, MA 02176

November 24, 2023
Christy Pat
3 Caledonia Ave
Quincy, MA 02169

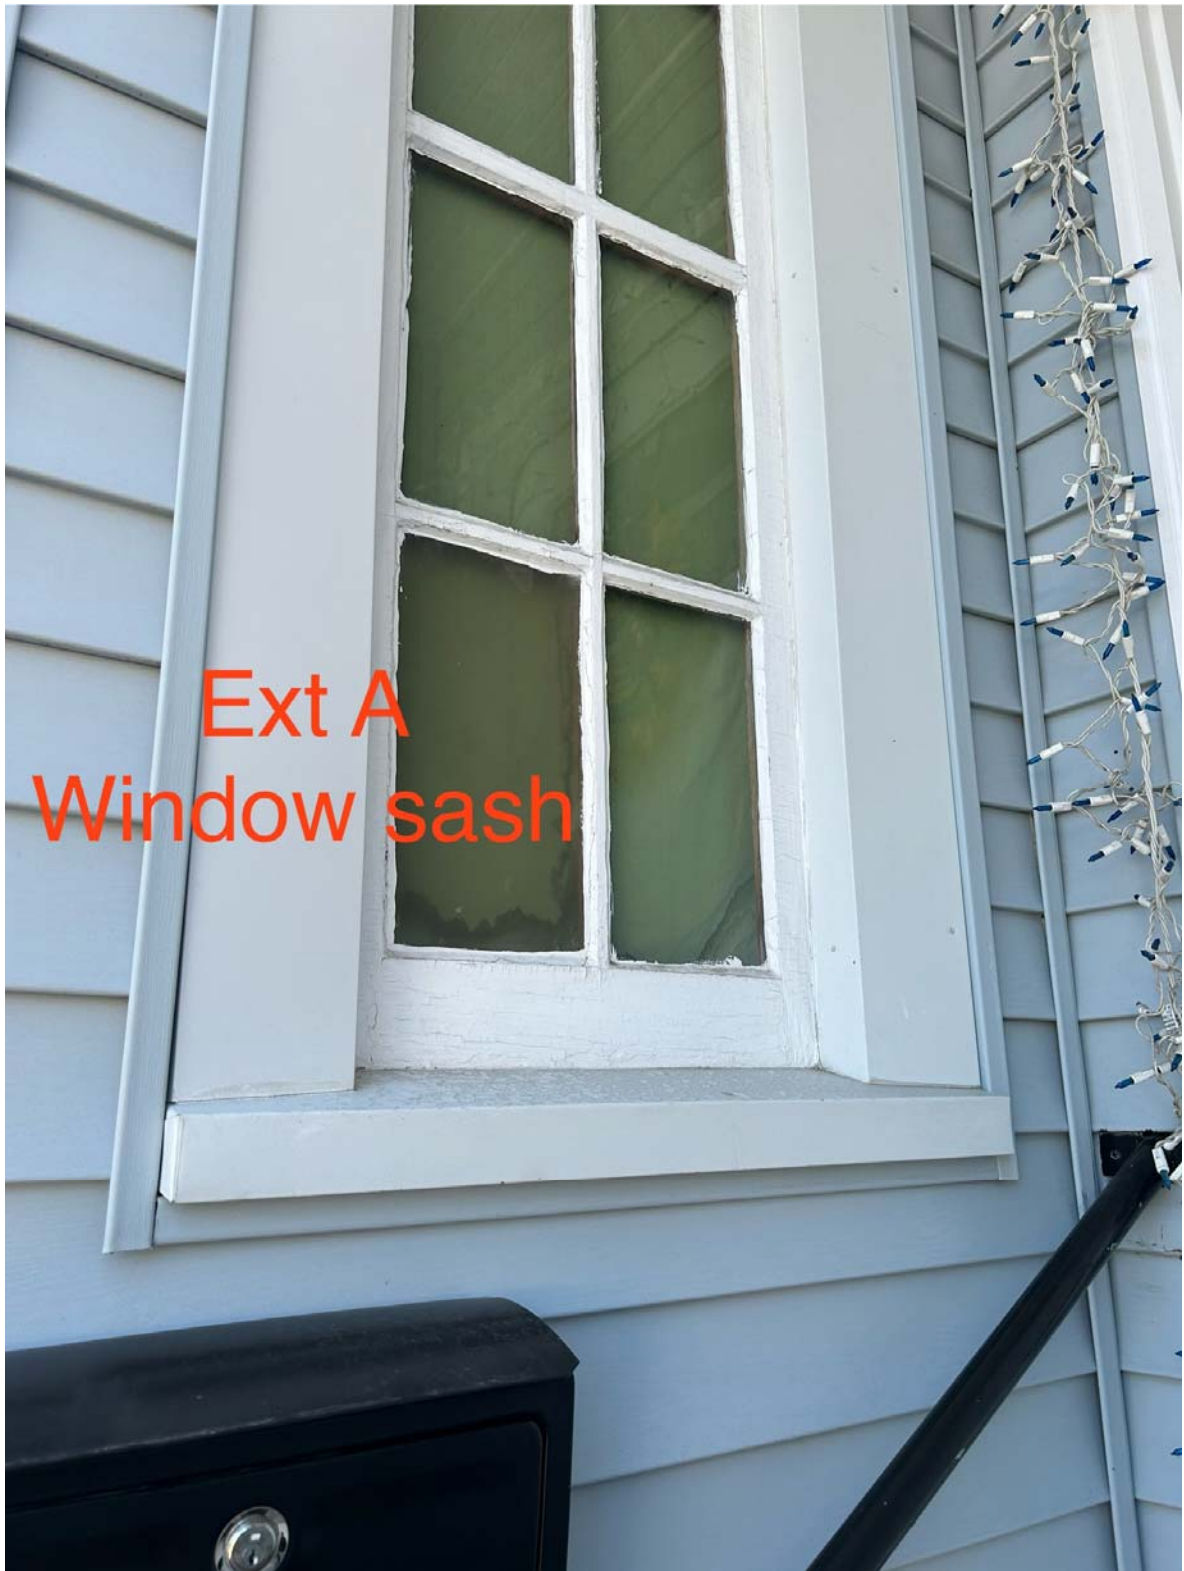
Ext A
Window sash

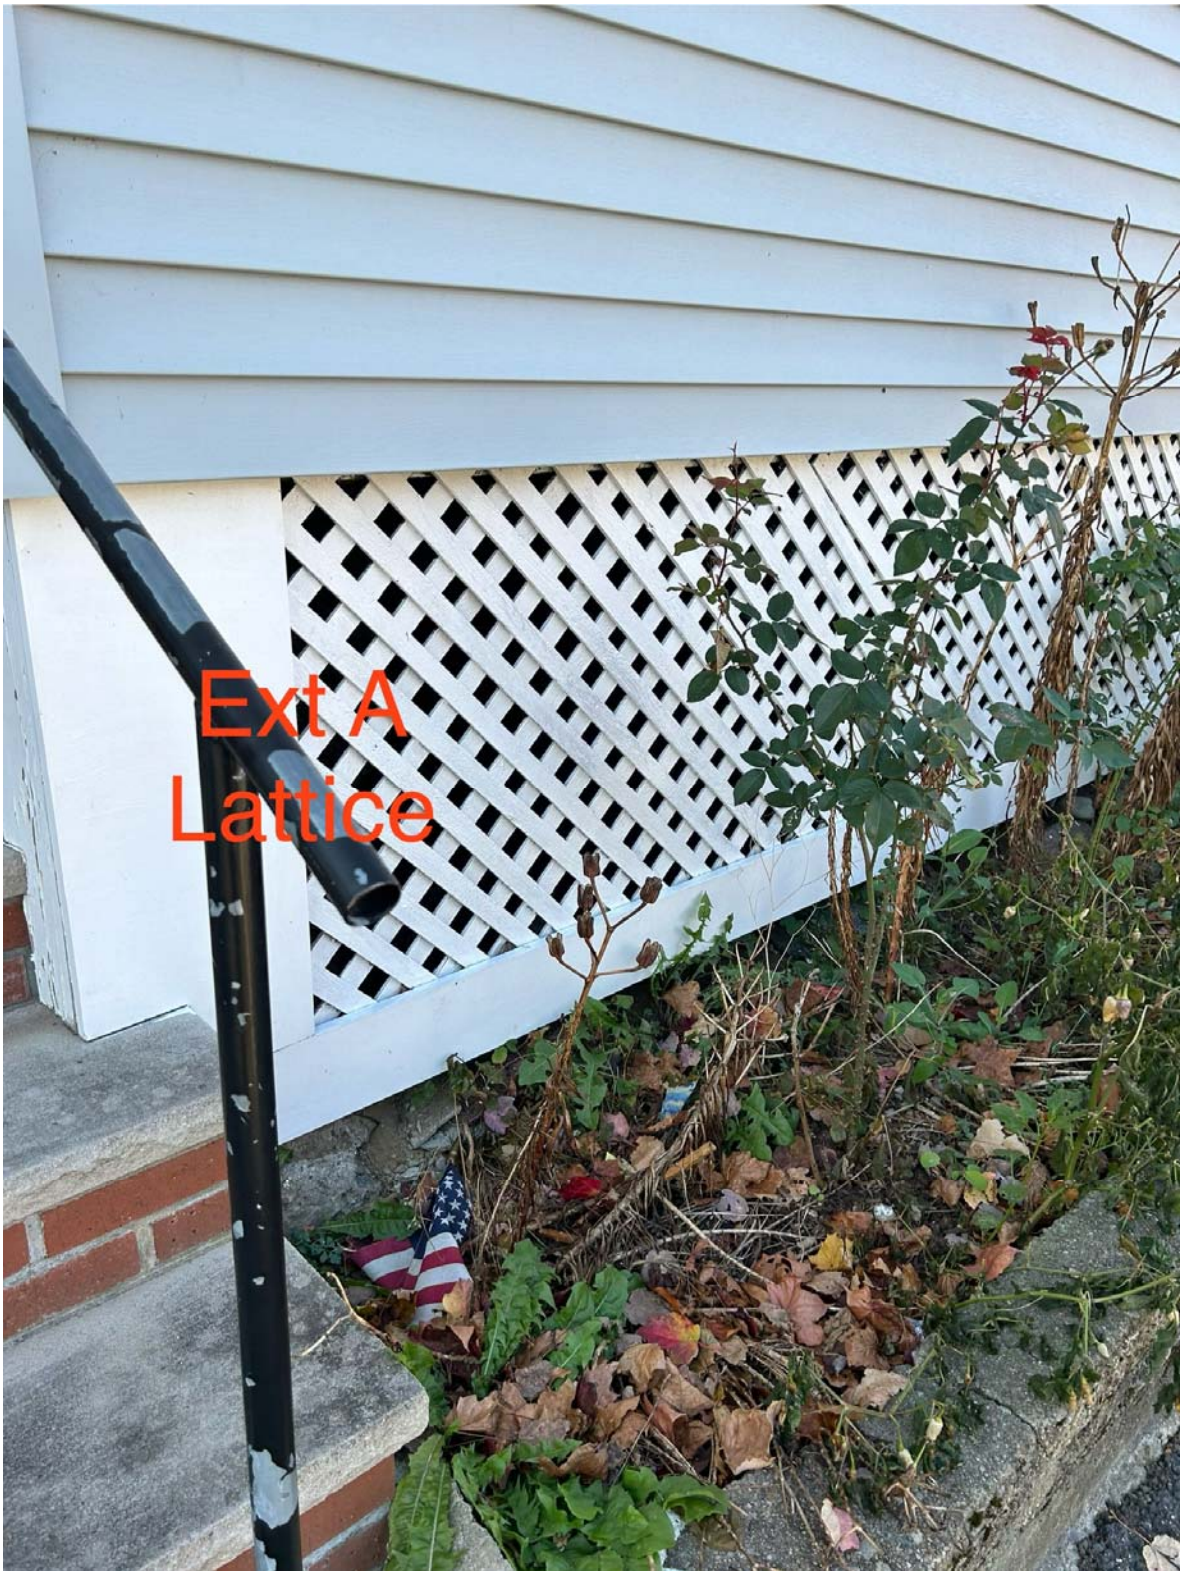
Ext A
Lattice

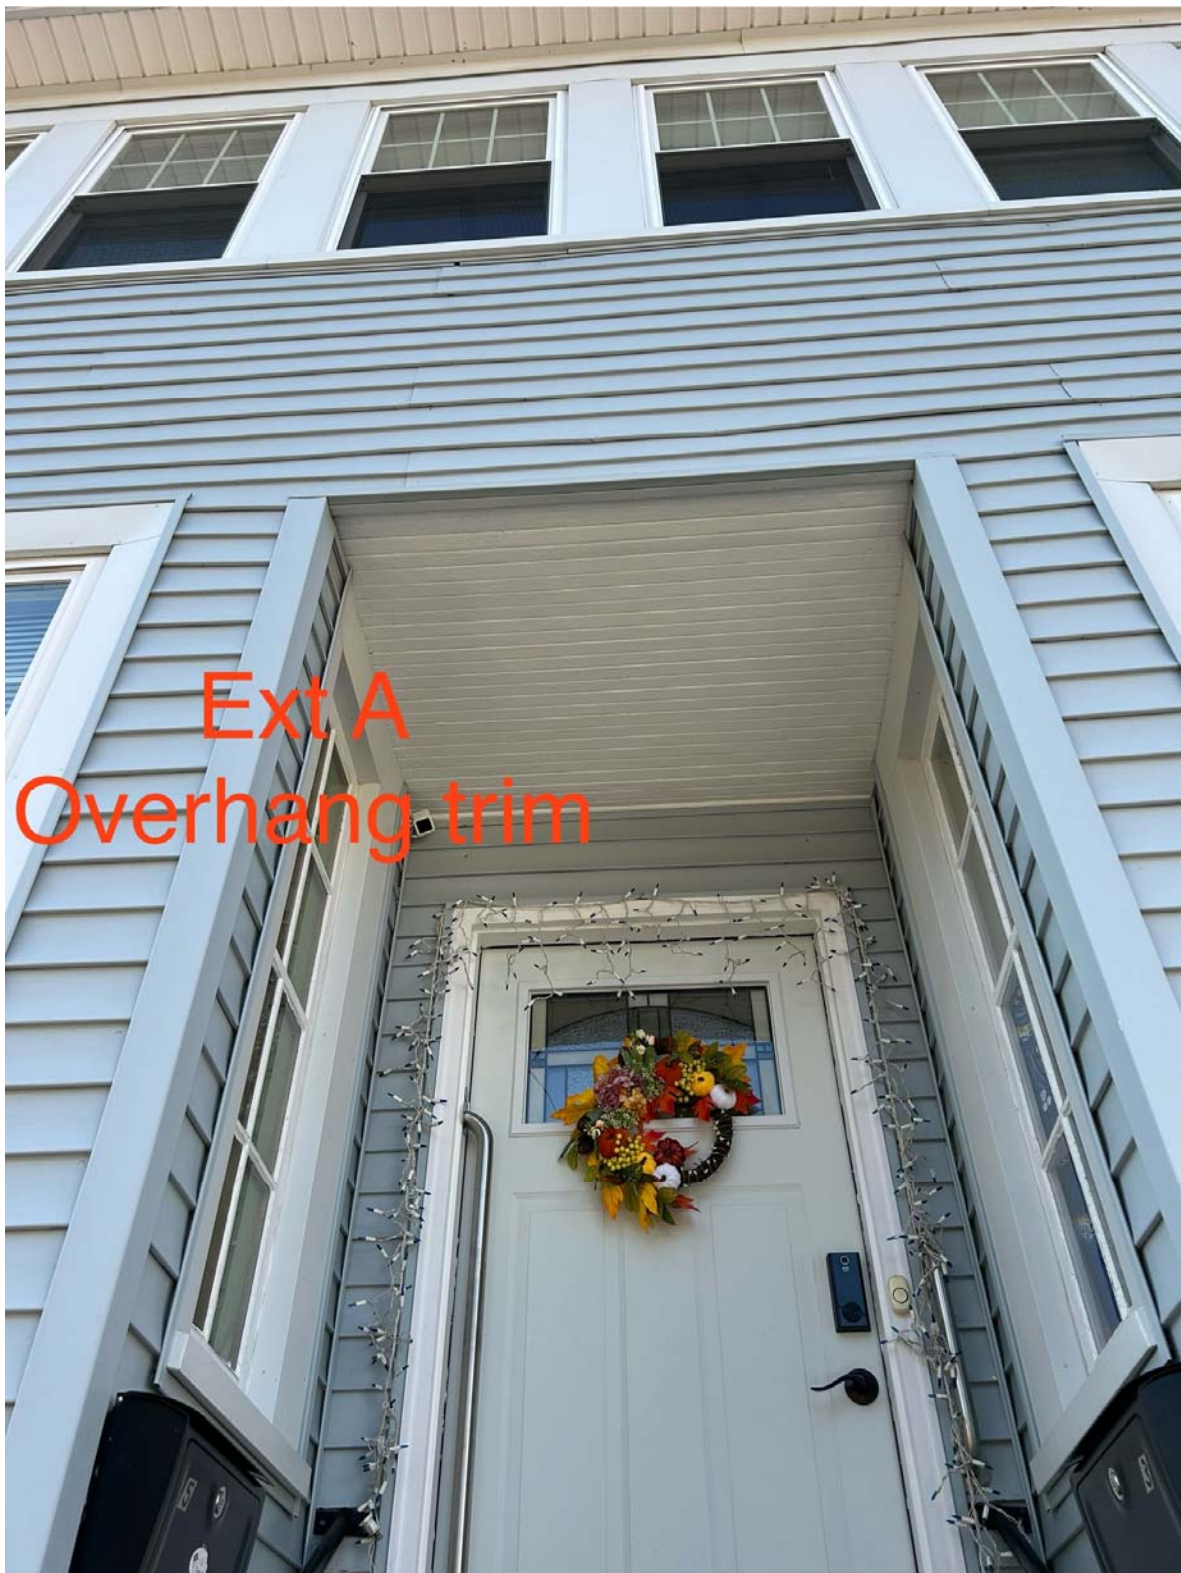
Ext A
Overhang trim

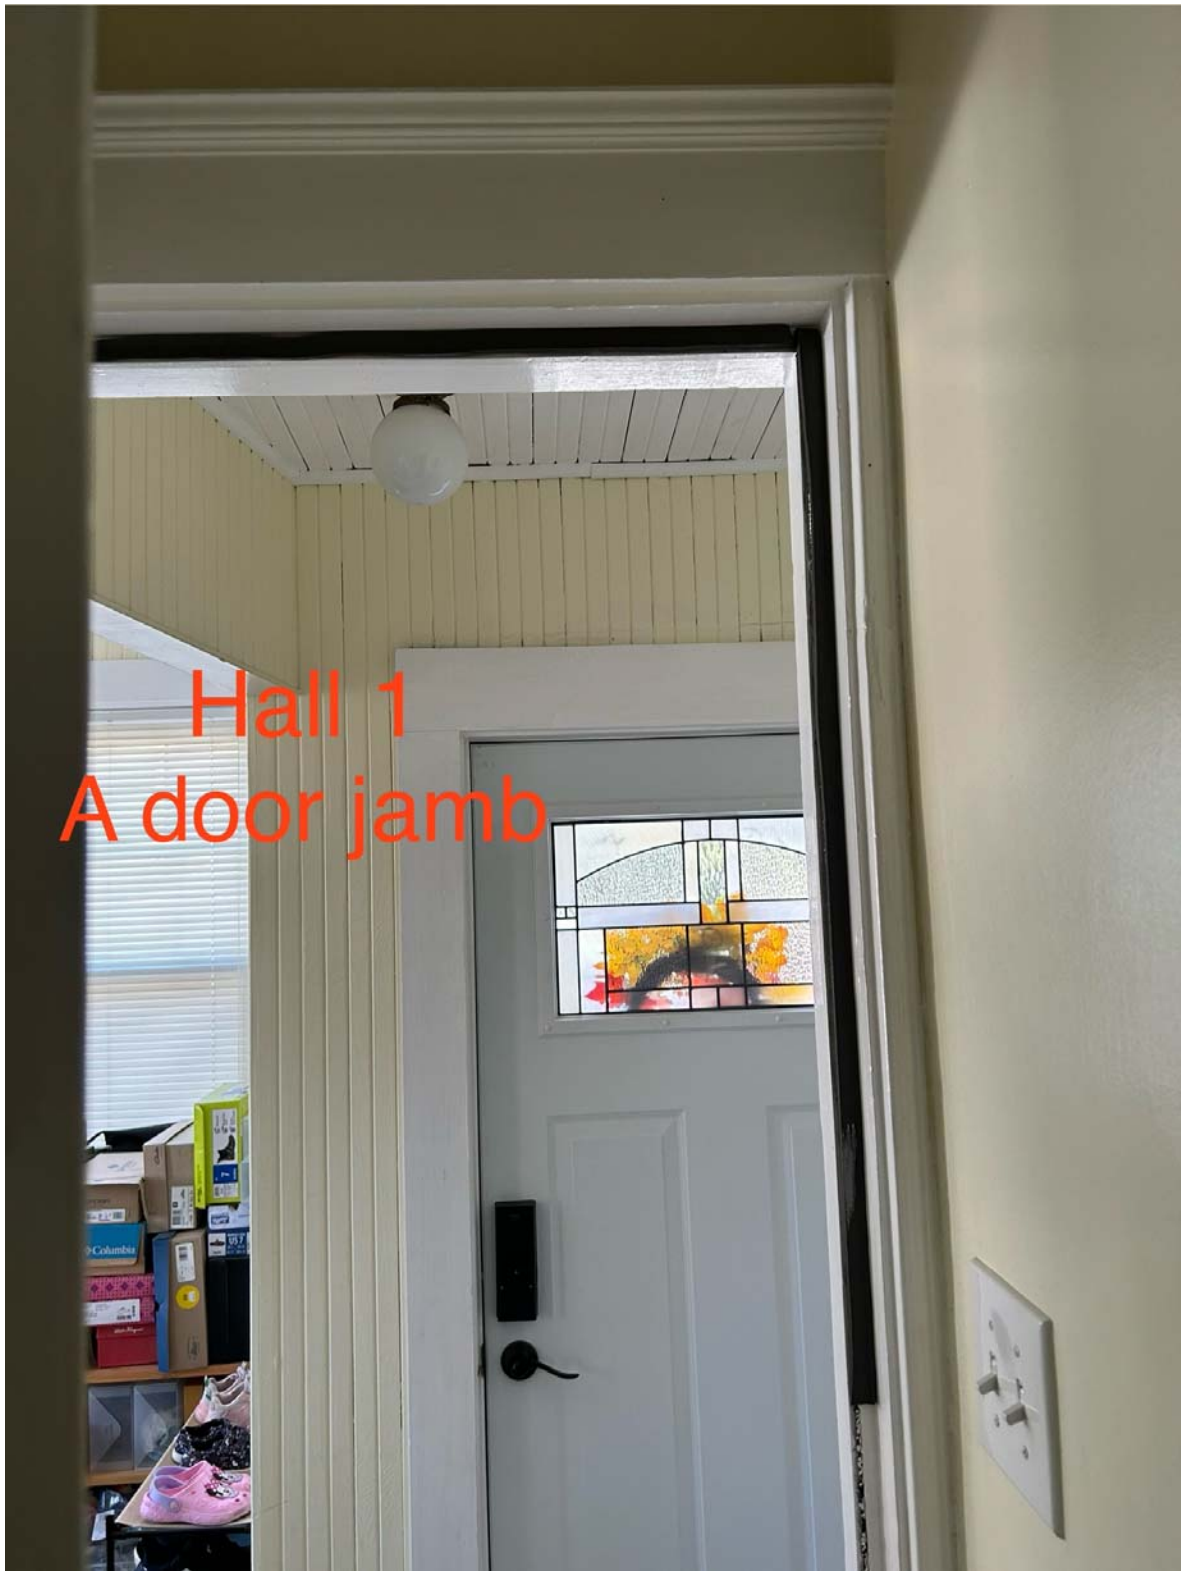
Hall 1
A door jamb

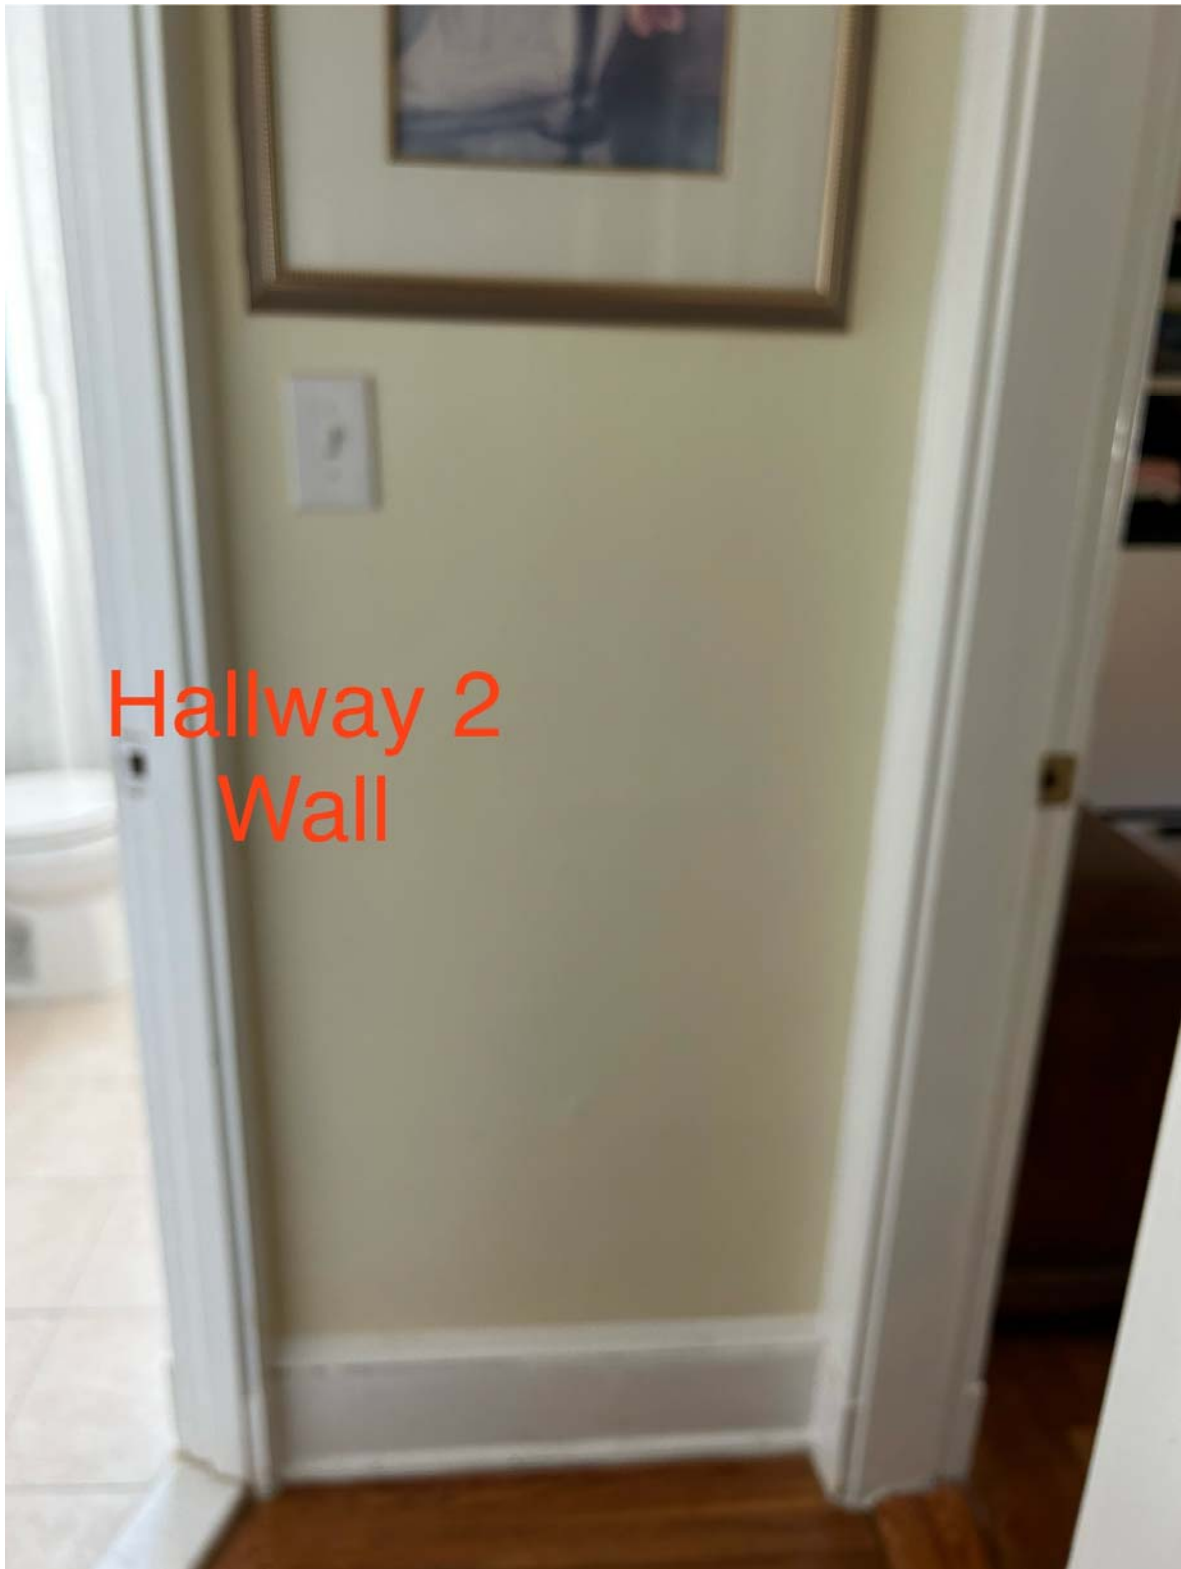
Hallway 2
Wall

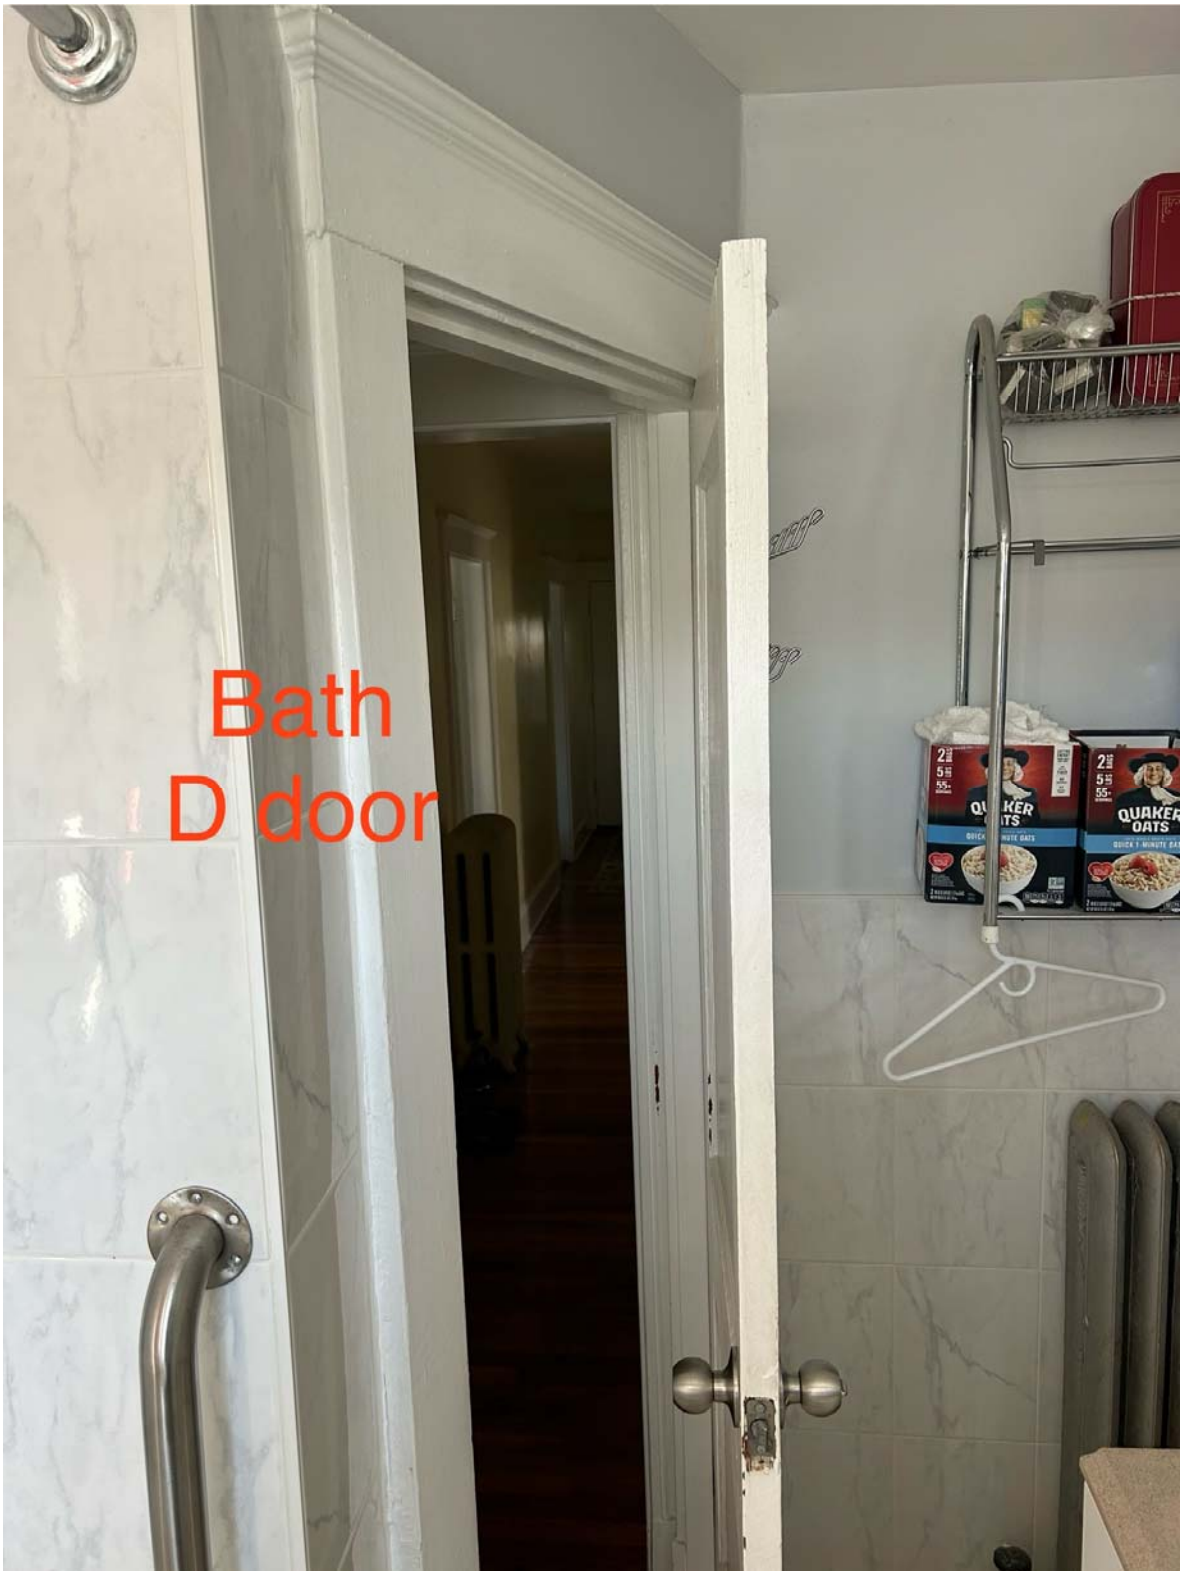
Bath
D door

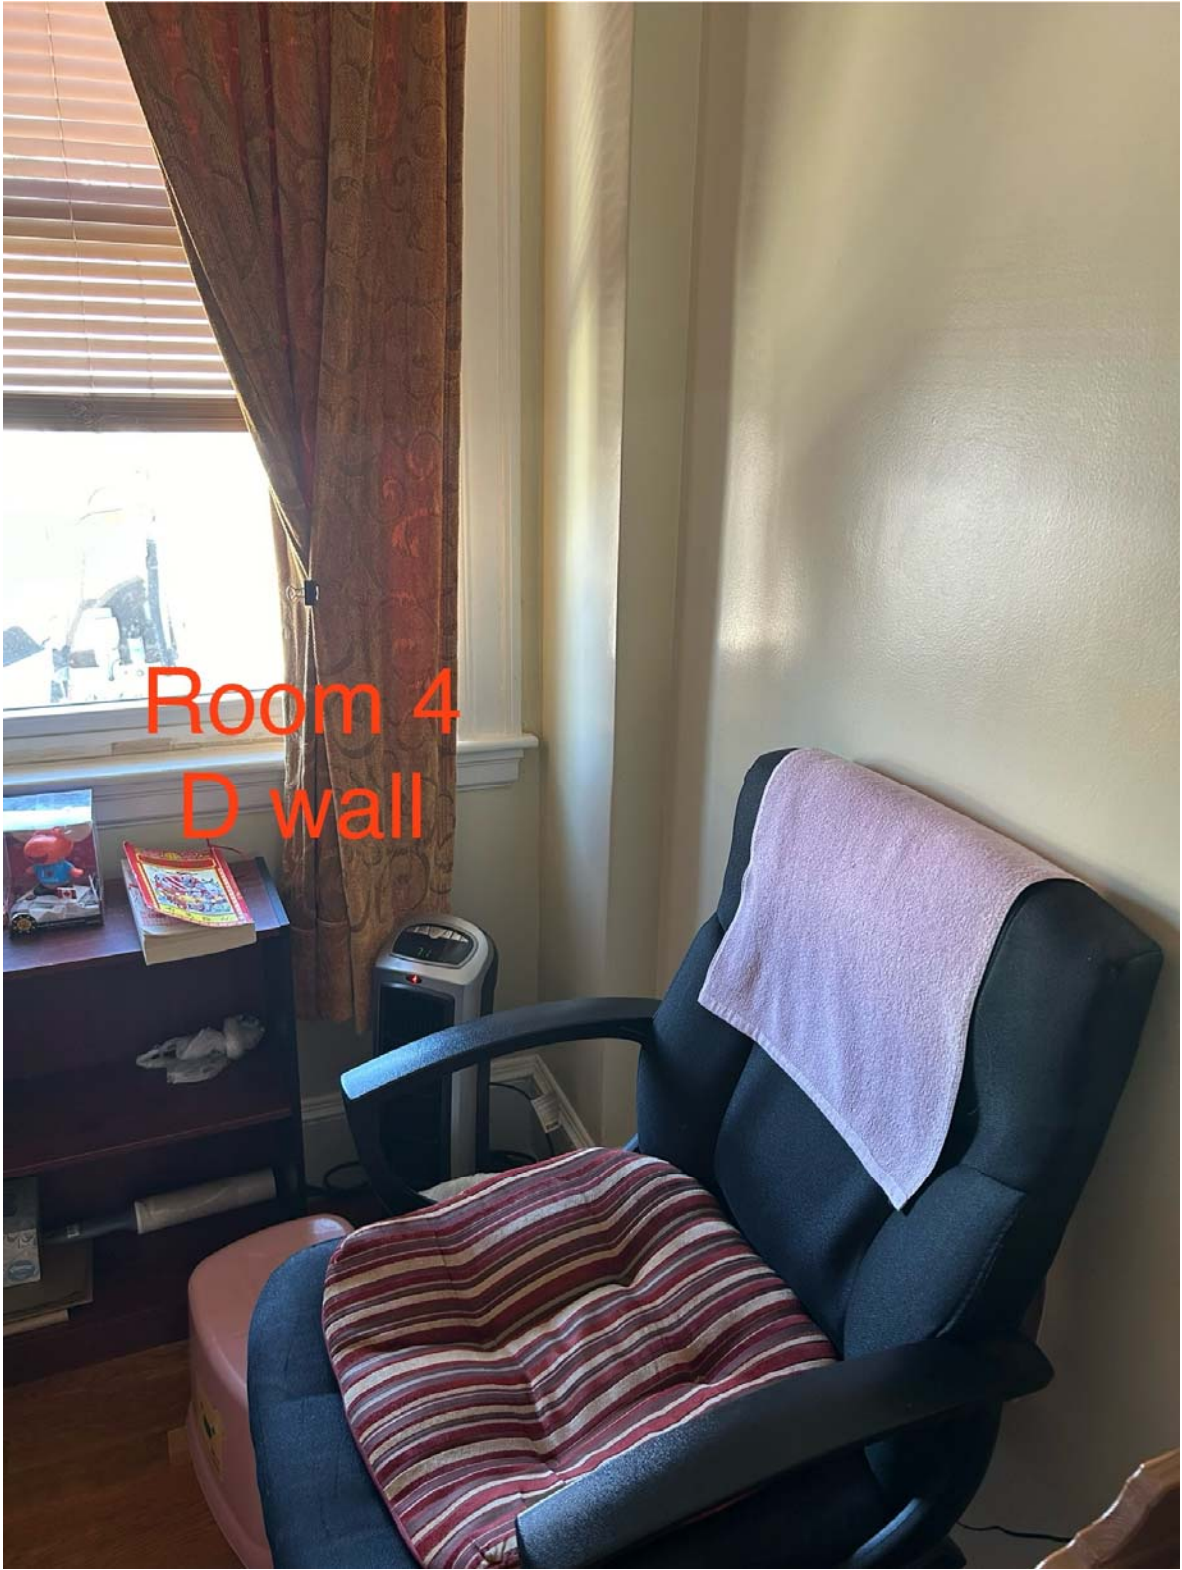
Room 4
D wall

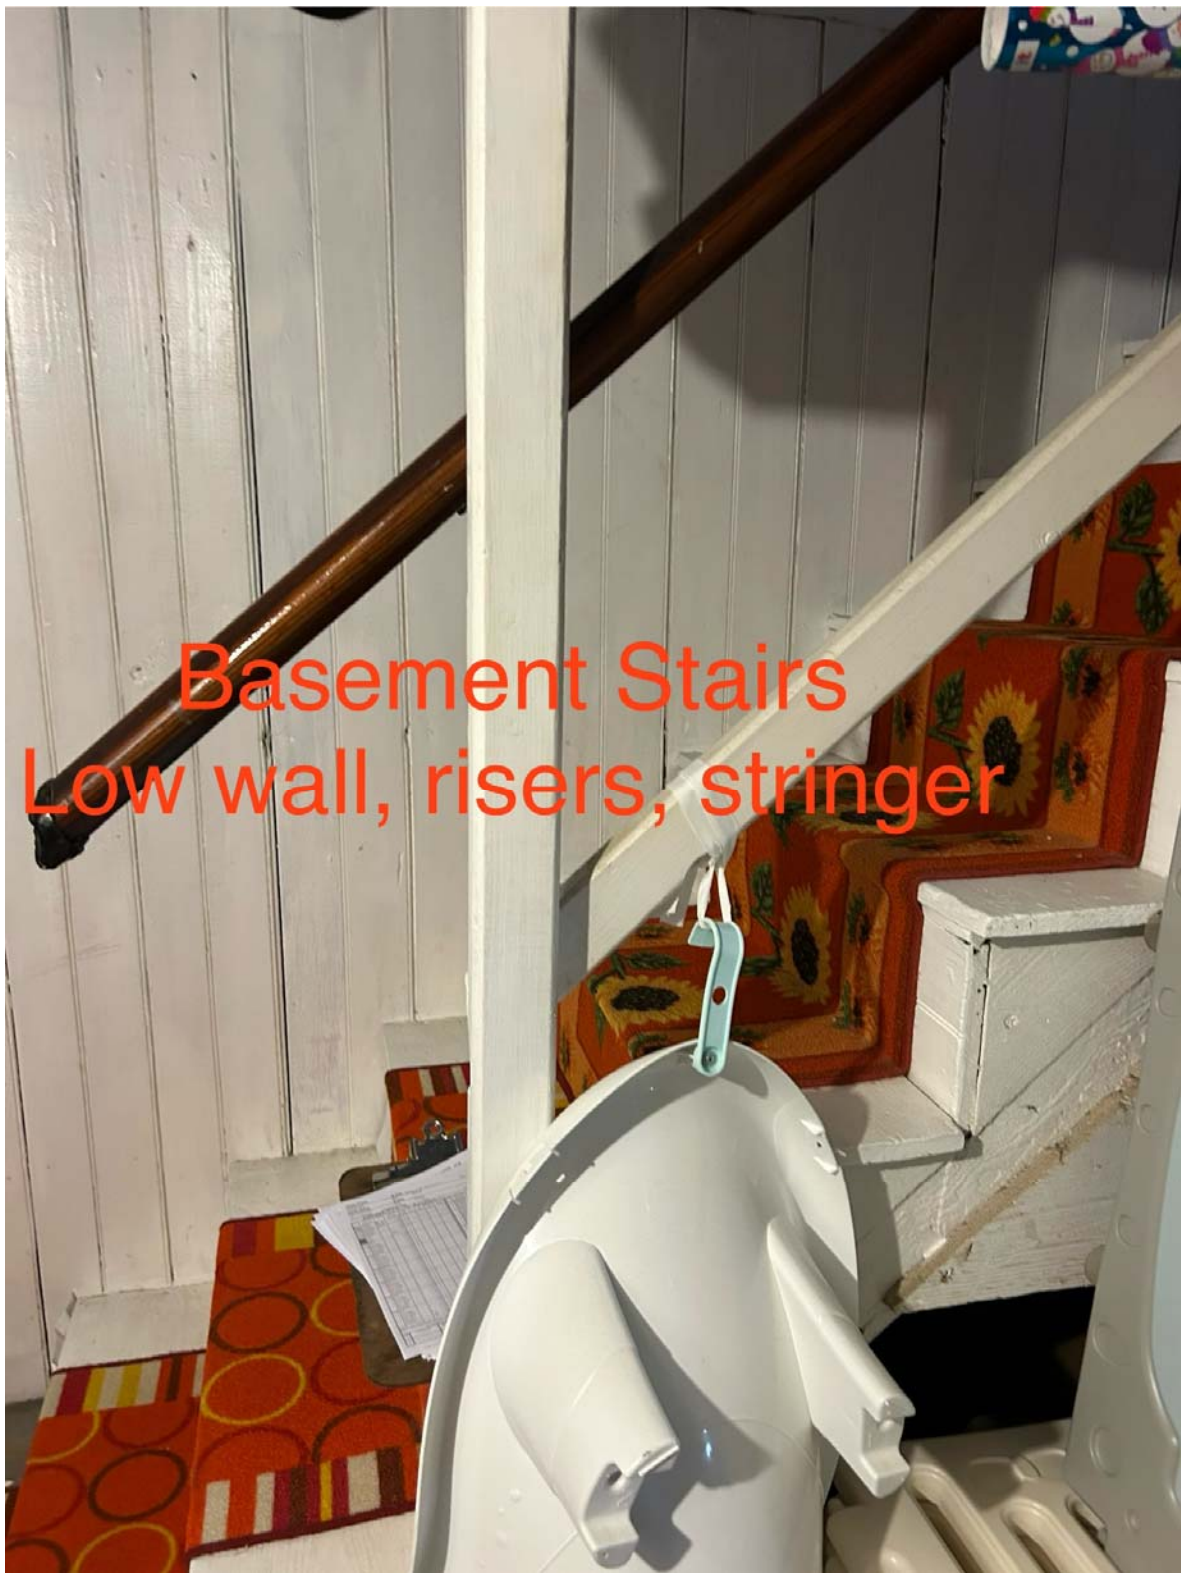
Basement Stairs
Low wall, risers, stringer

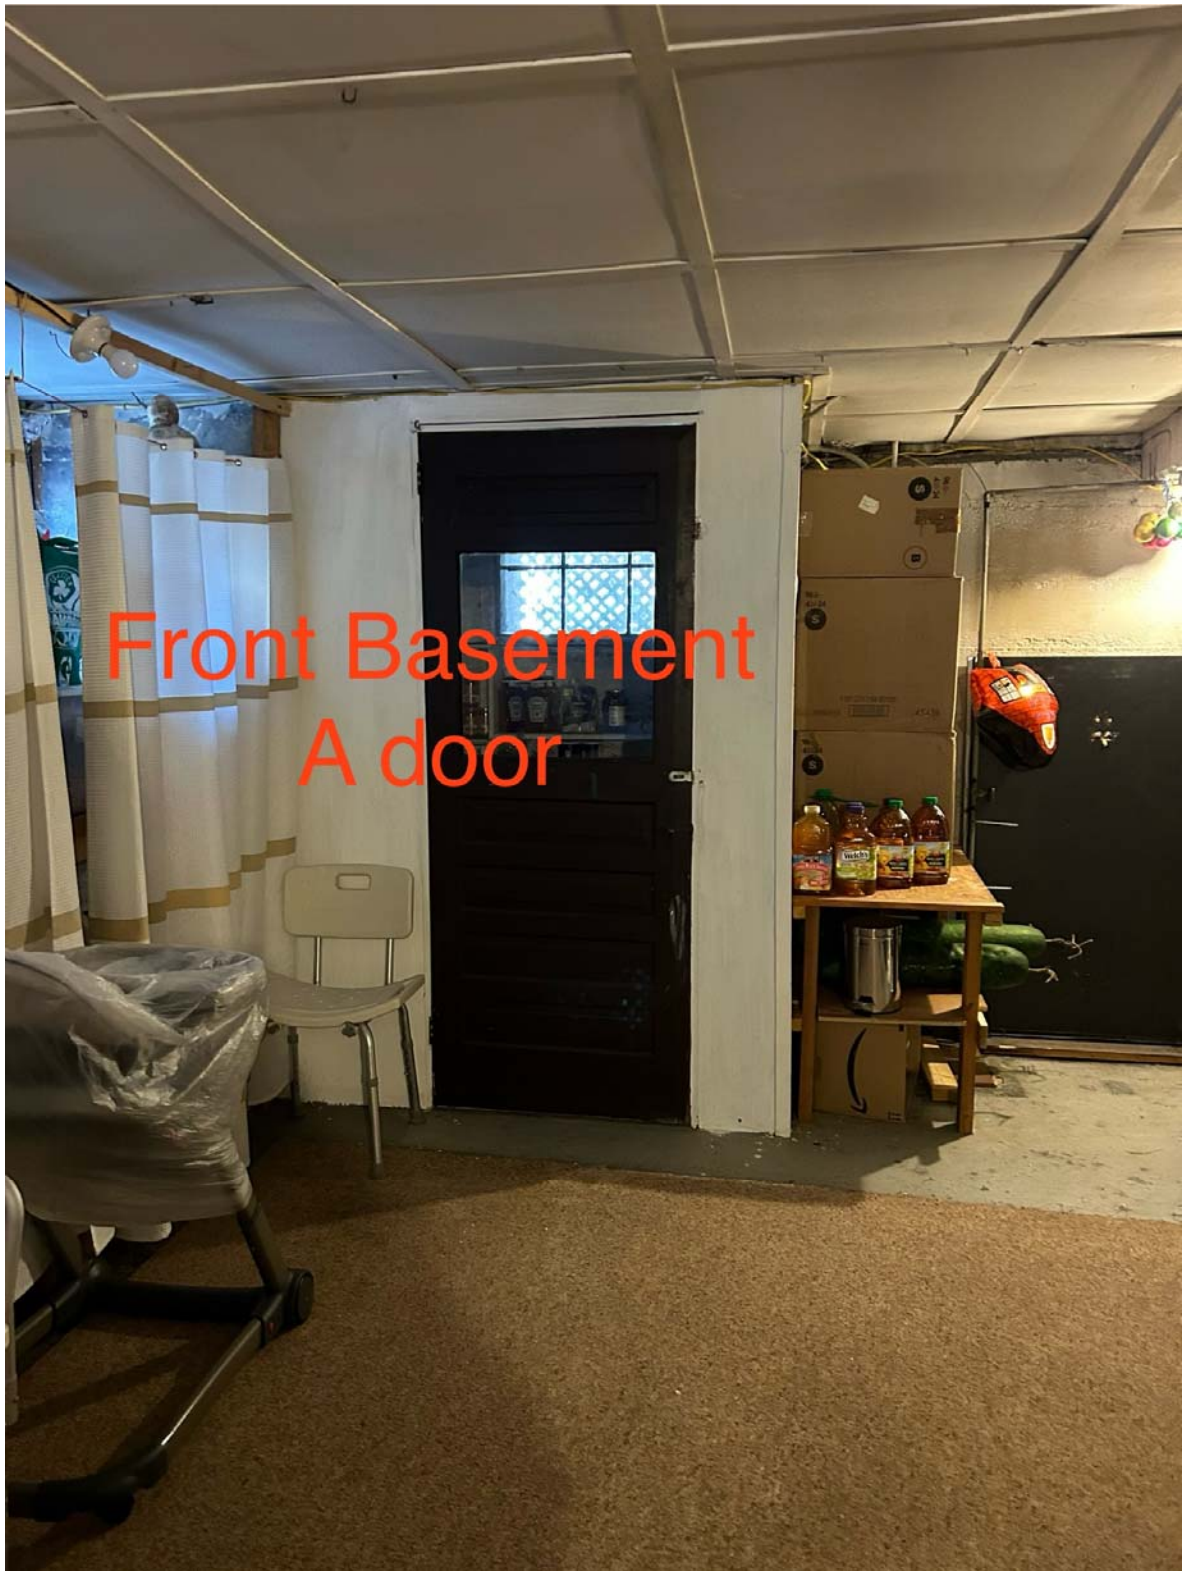
Front Basement
A door

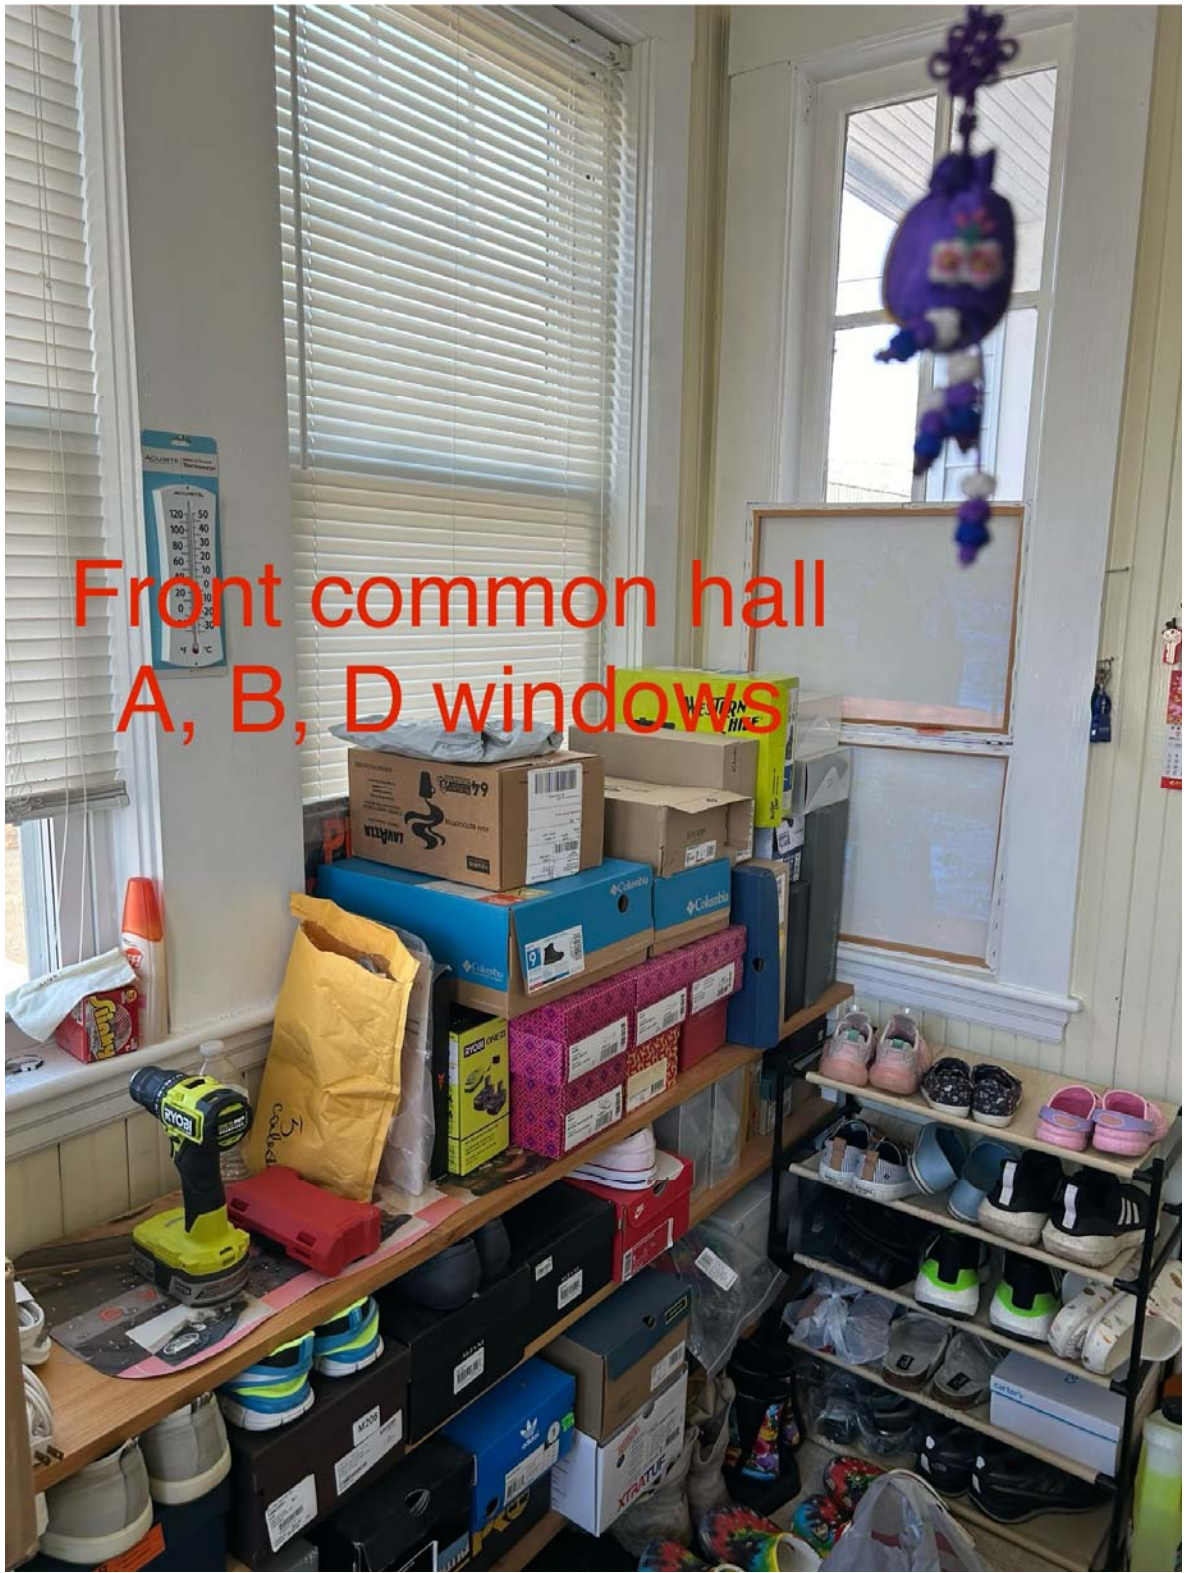
Front common hall
A, B, D windows

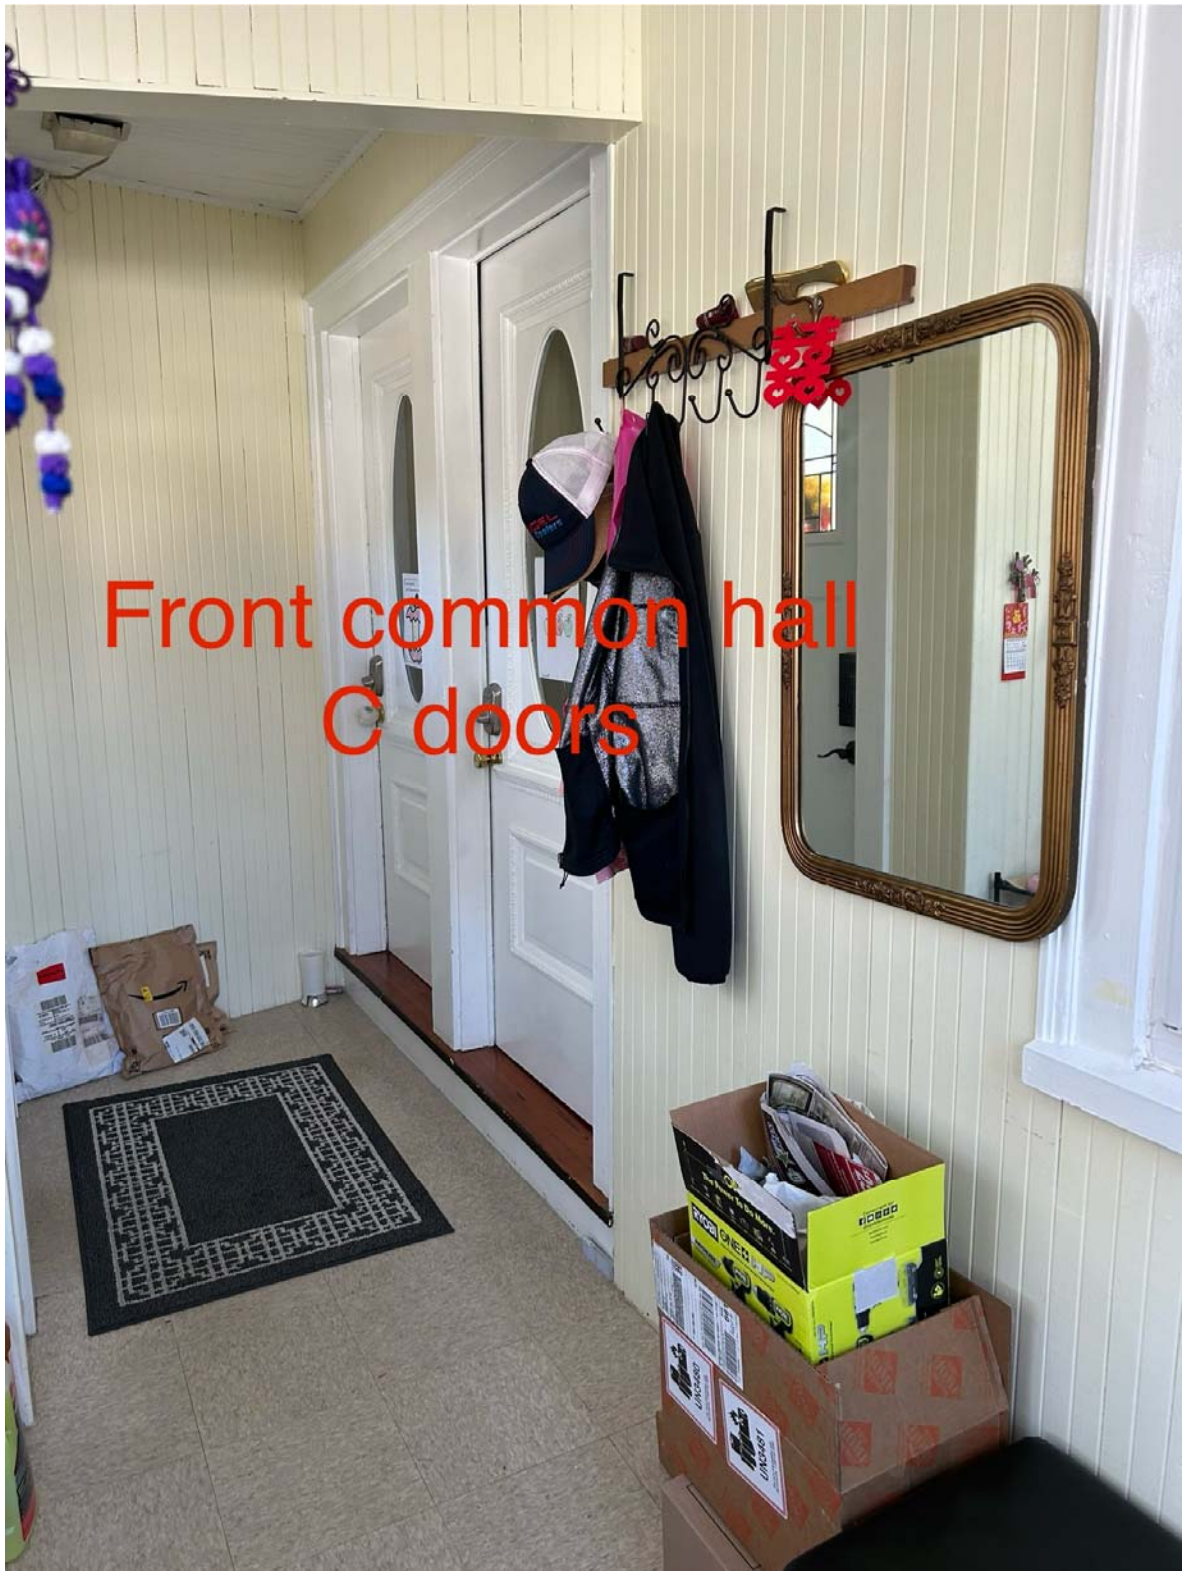
Front common hall
C doors

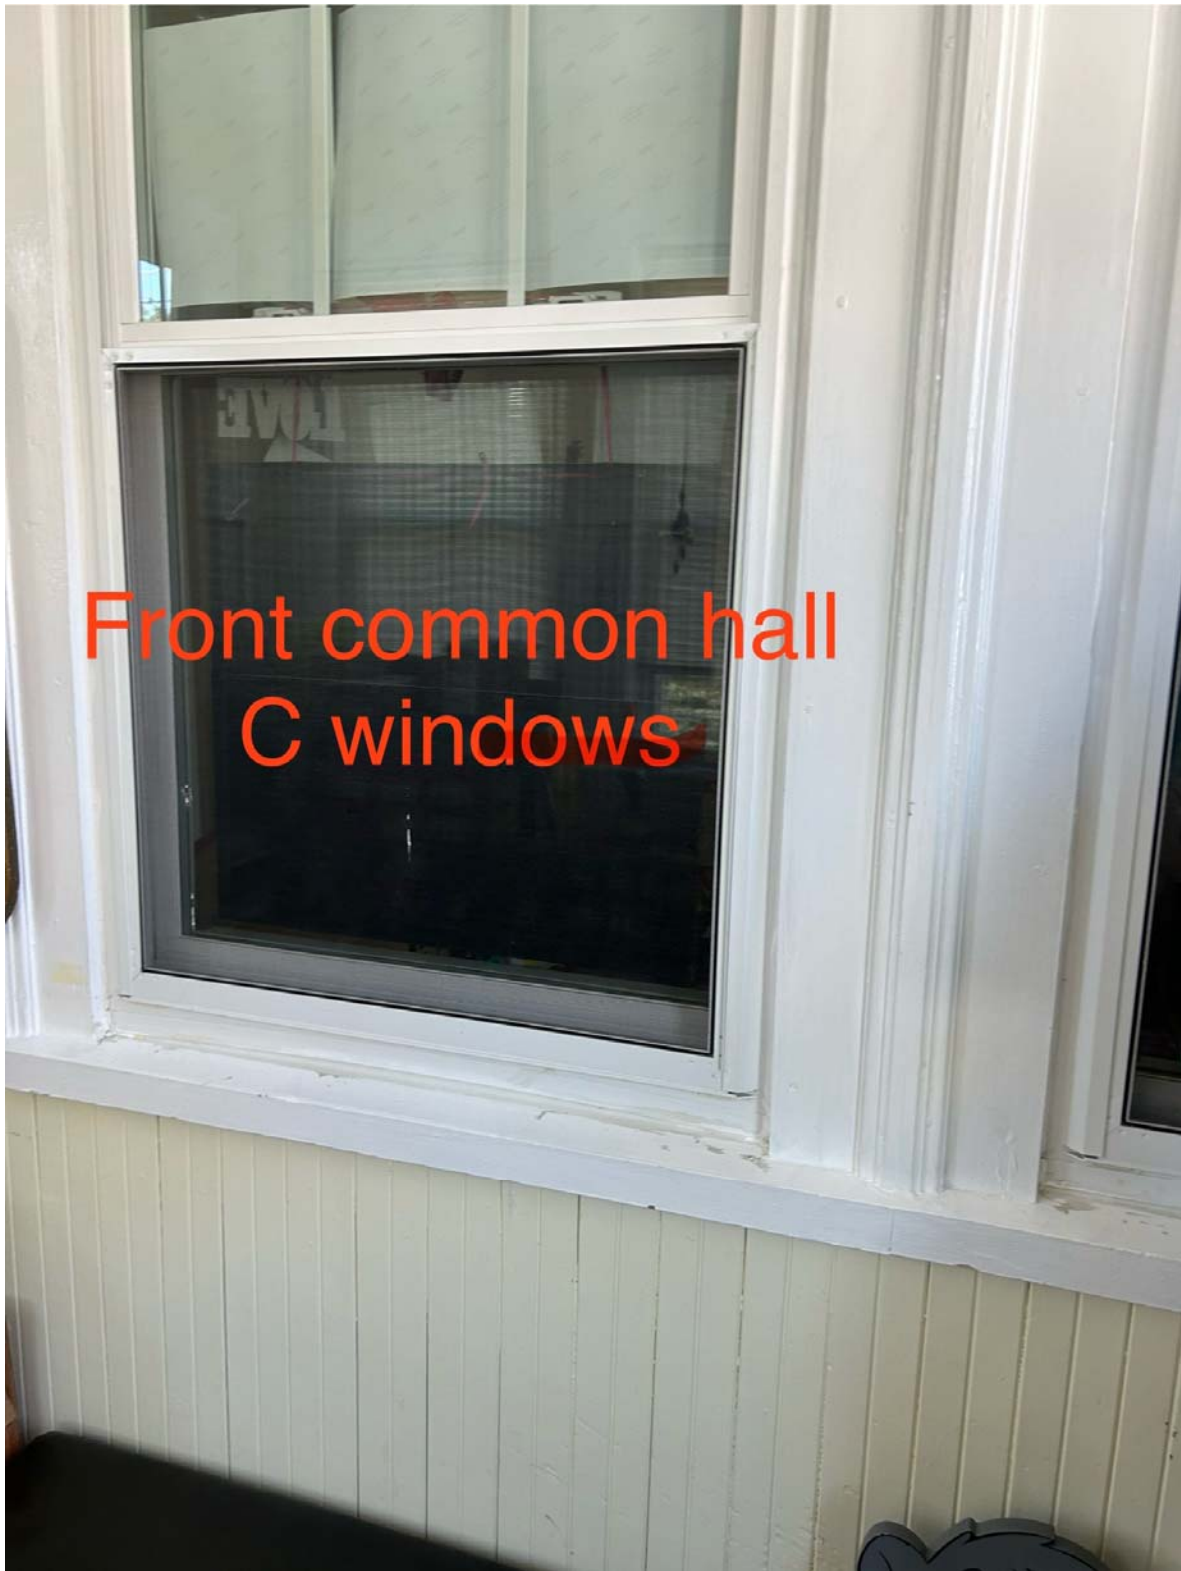
Front common hall
C windows
