Lead-Based Paint Testing and Lead Hazard Risk Assessment Report

PERFORMED AT:
3 Caledonia Ave
Quincy, MA 02169

PREPARED BY:
Titan Lead Testing, LLC
MA License # MI/R 4025
Expires 04/26/2024
PO Box 760709
Melrose, MA 02176

November 24, 2023
Christy Pat
3 Caledonia Ave
Quincy, MA 02169

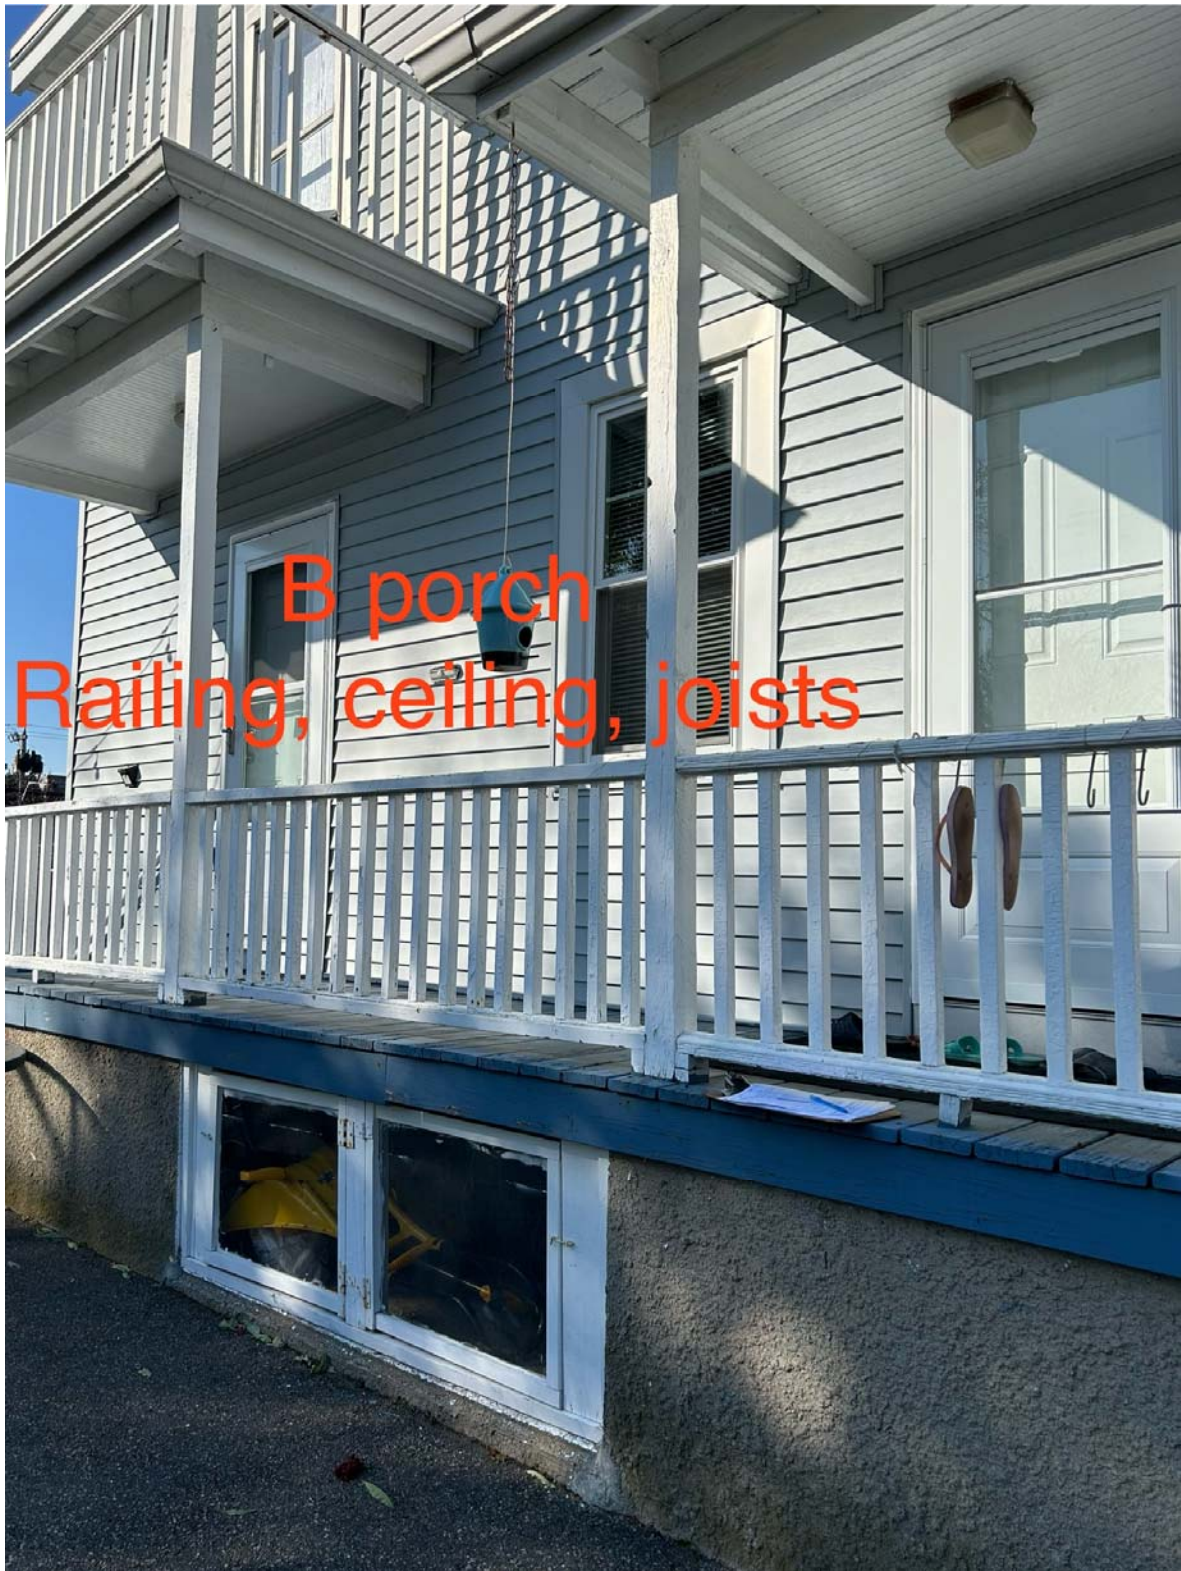
B porch
Railing, ceiling, joists

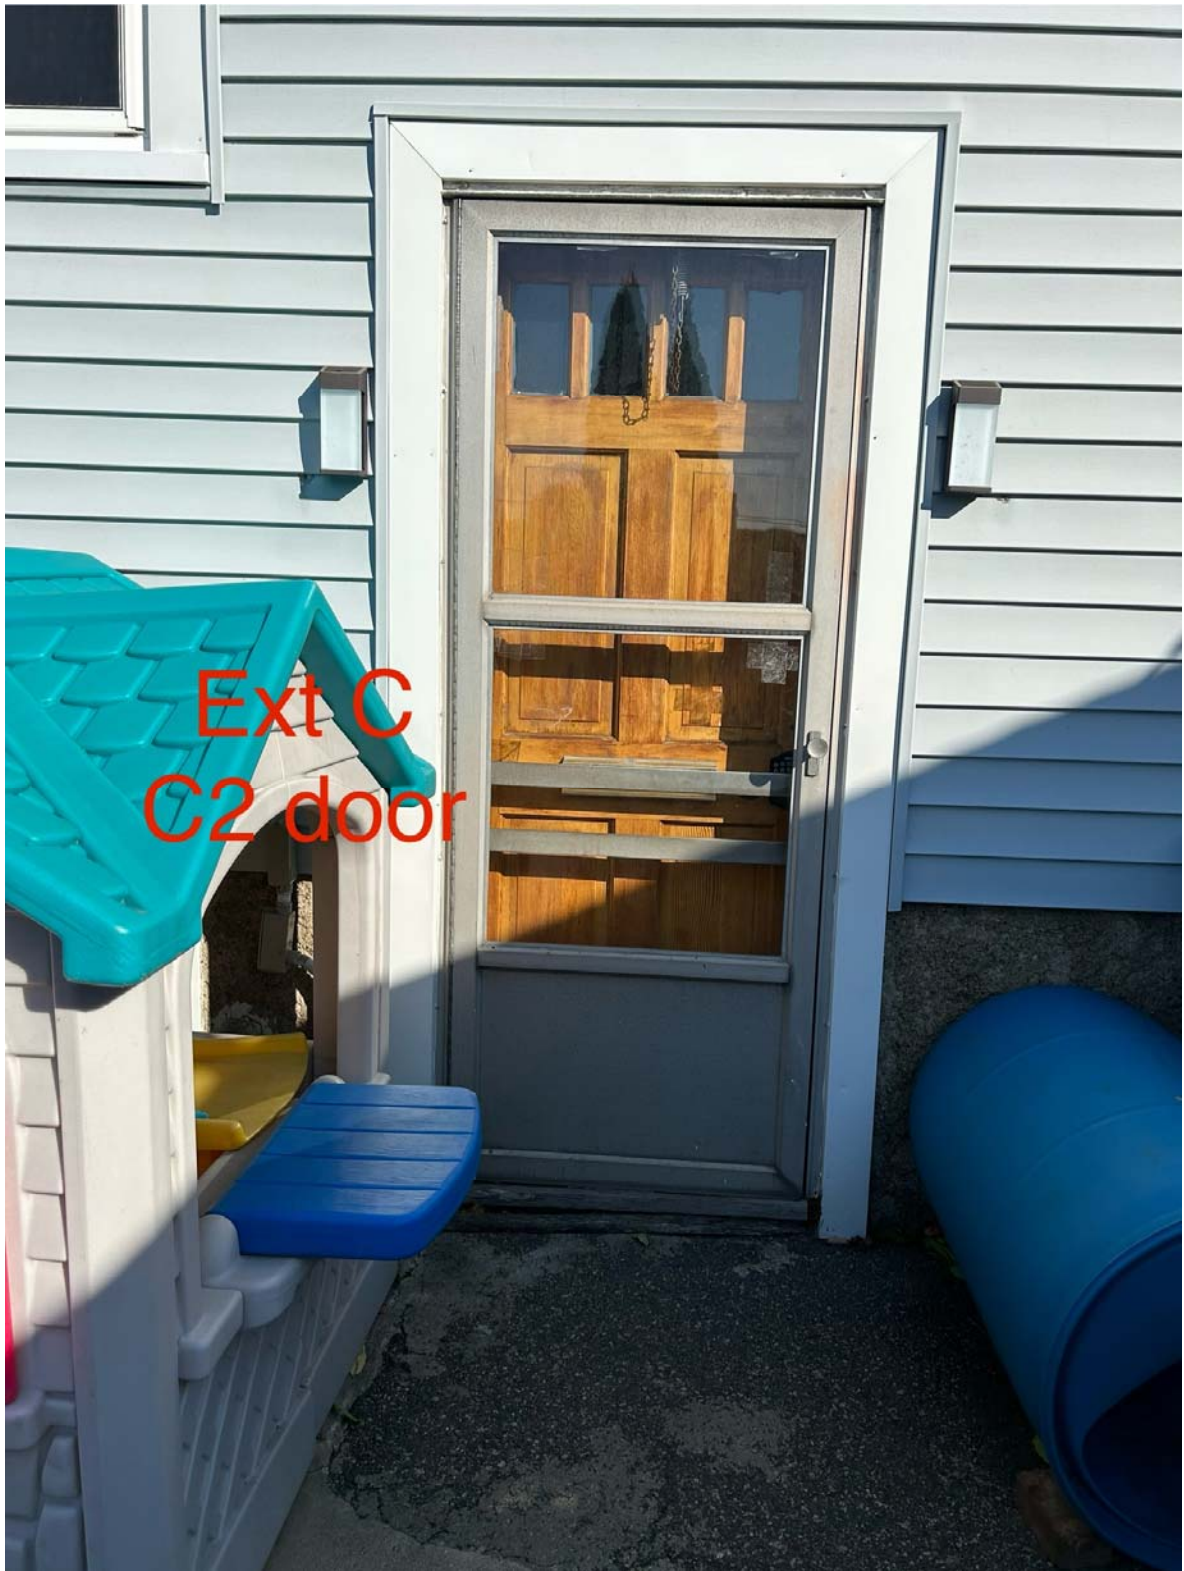
Ext C
C2 door

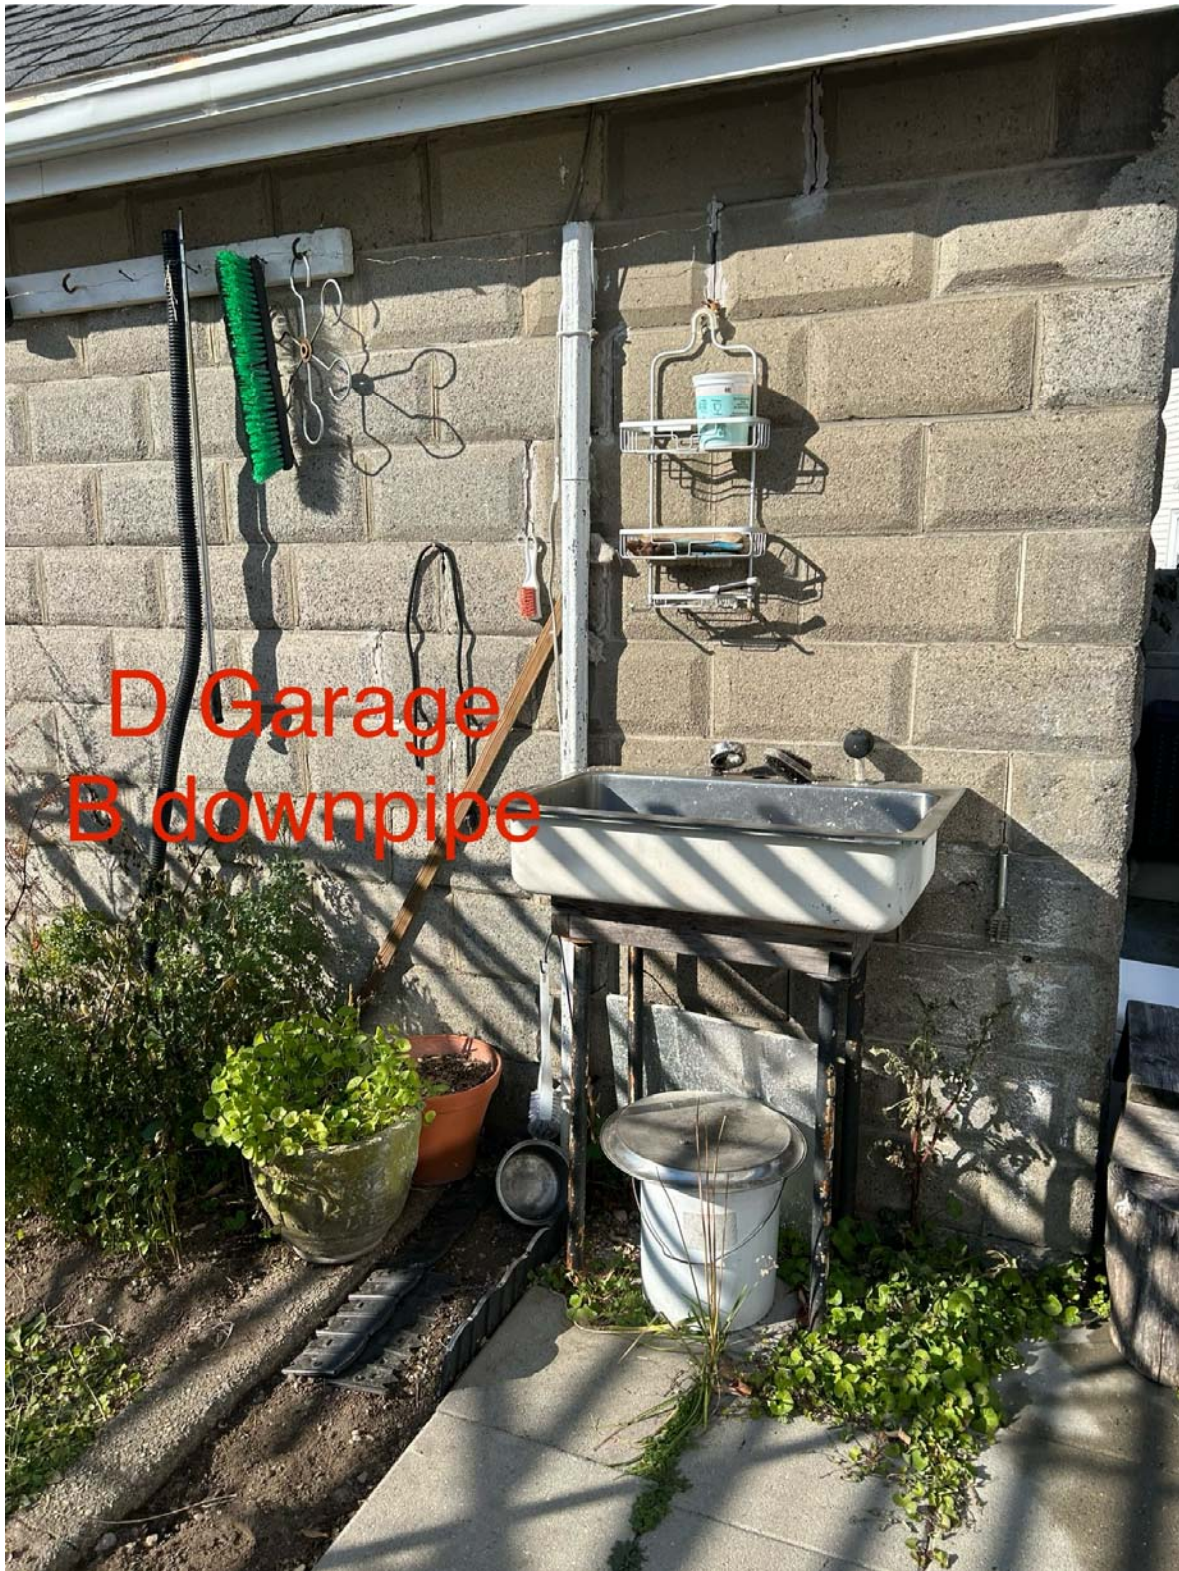
D Garage
B downpipe

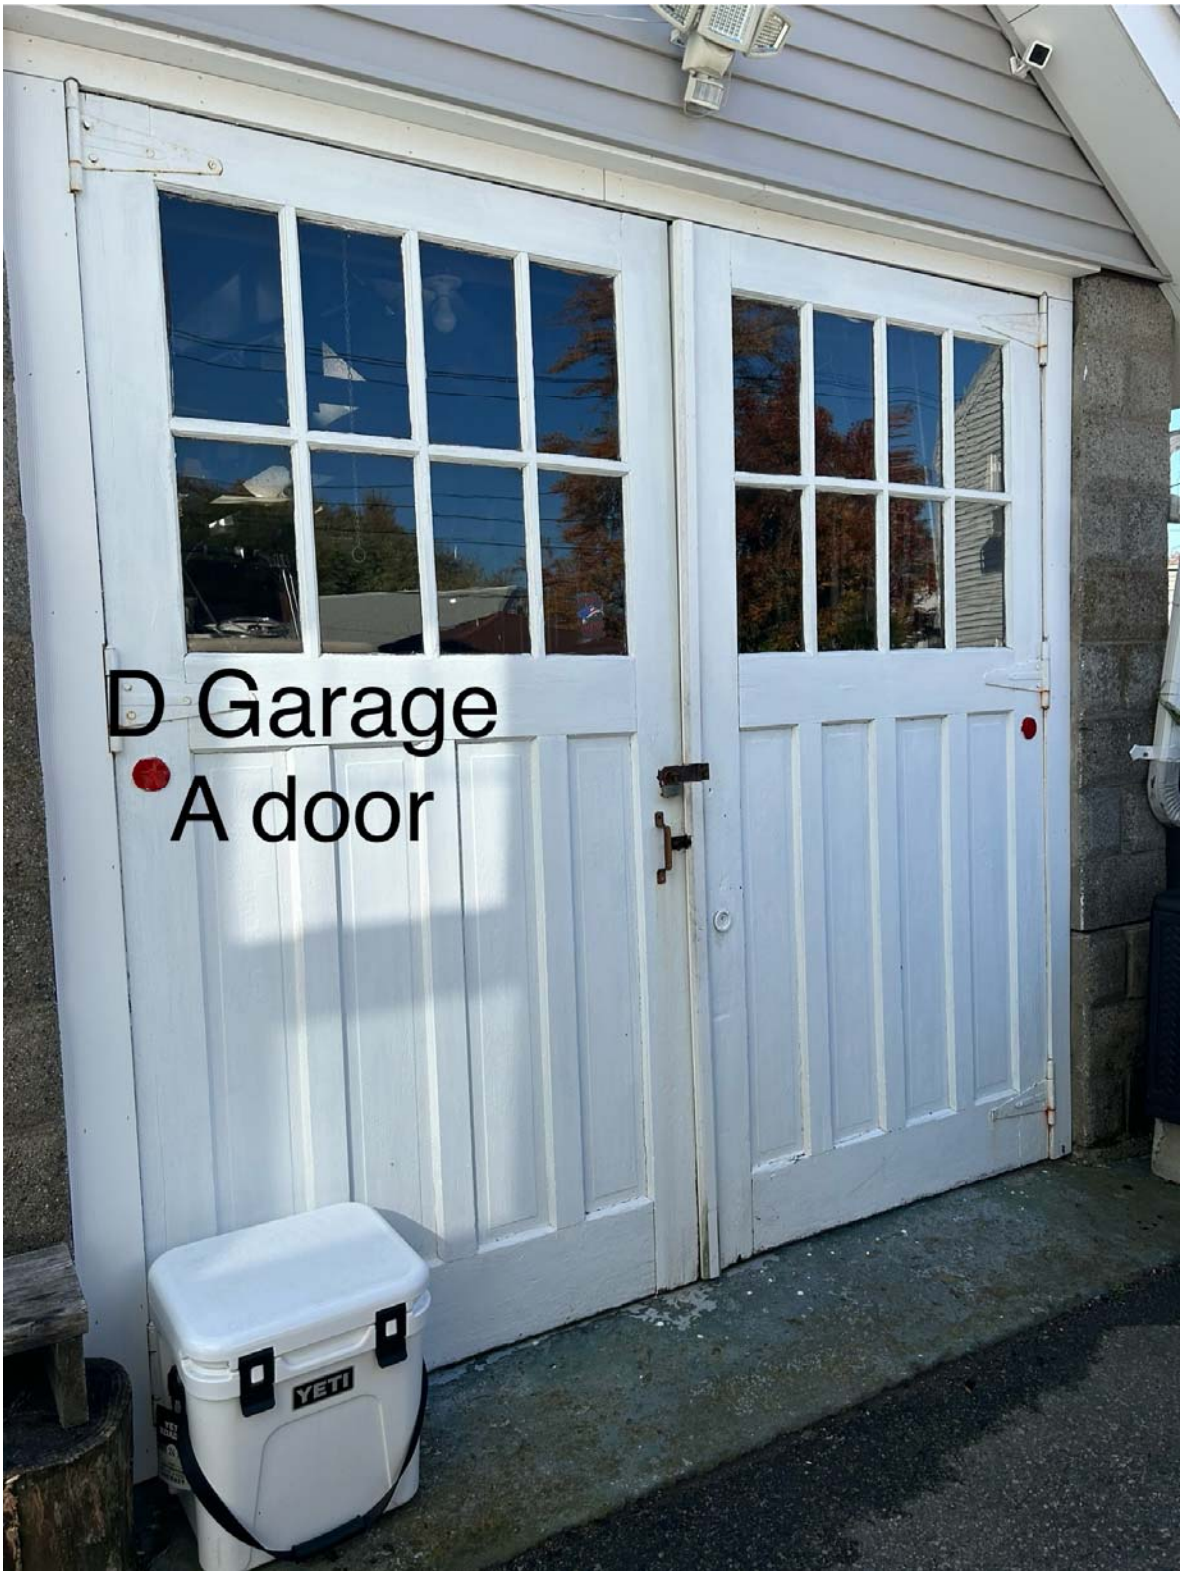
D Garage
A door
