# Lead-Based Paint Testing and Lead Hazard Risk Assessment Report

PERFORMED AT:  
465 Beale St.  
Quincy, MA 02169

PREPARED BY:  
Titan Lead Testing, LLC  
MA License # MI/R 4025  
Expires 04/26/2023  
PO Box 760709  
Melrose, MA 02176

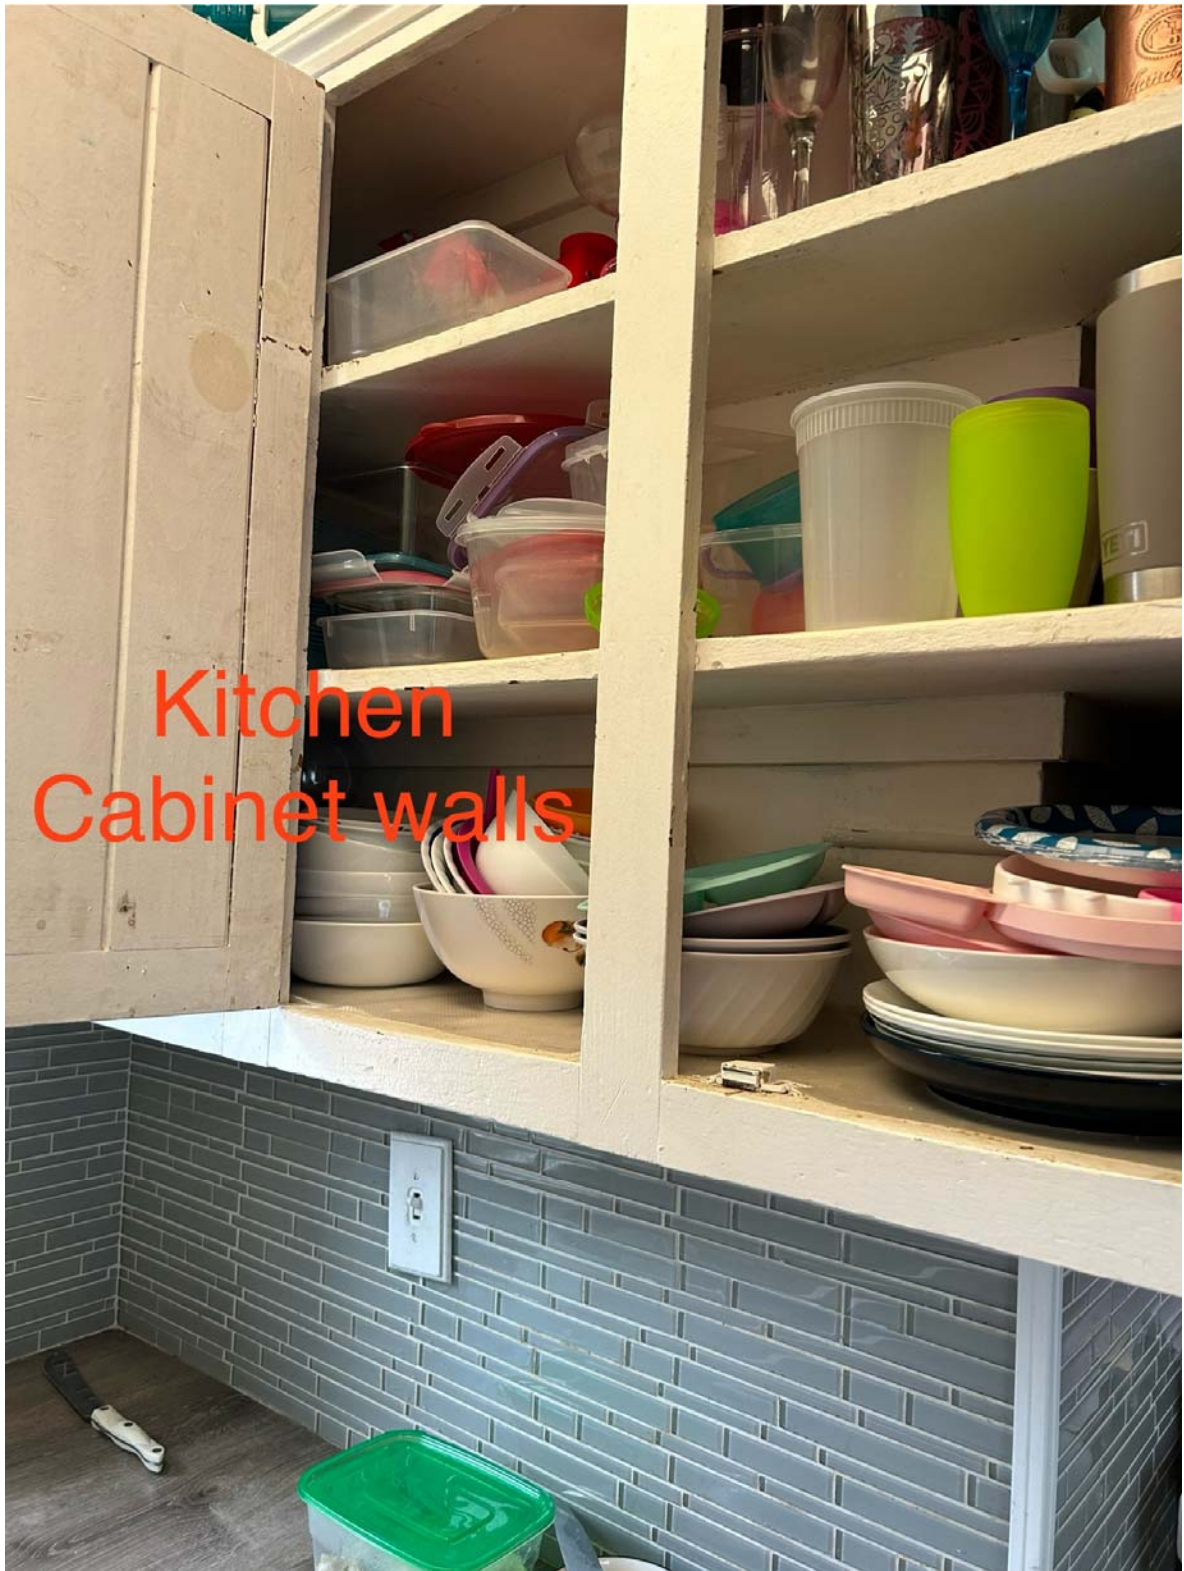
Kitchen  
Cabinet walls

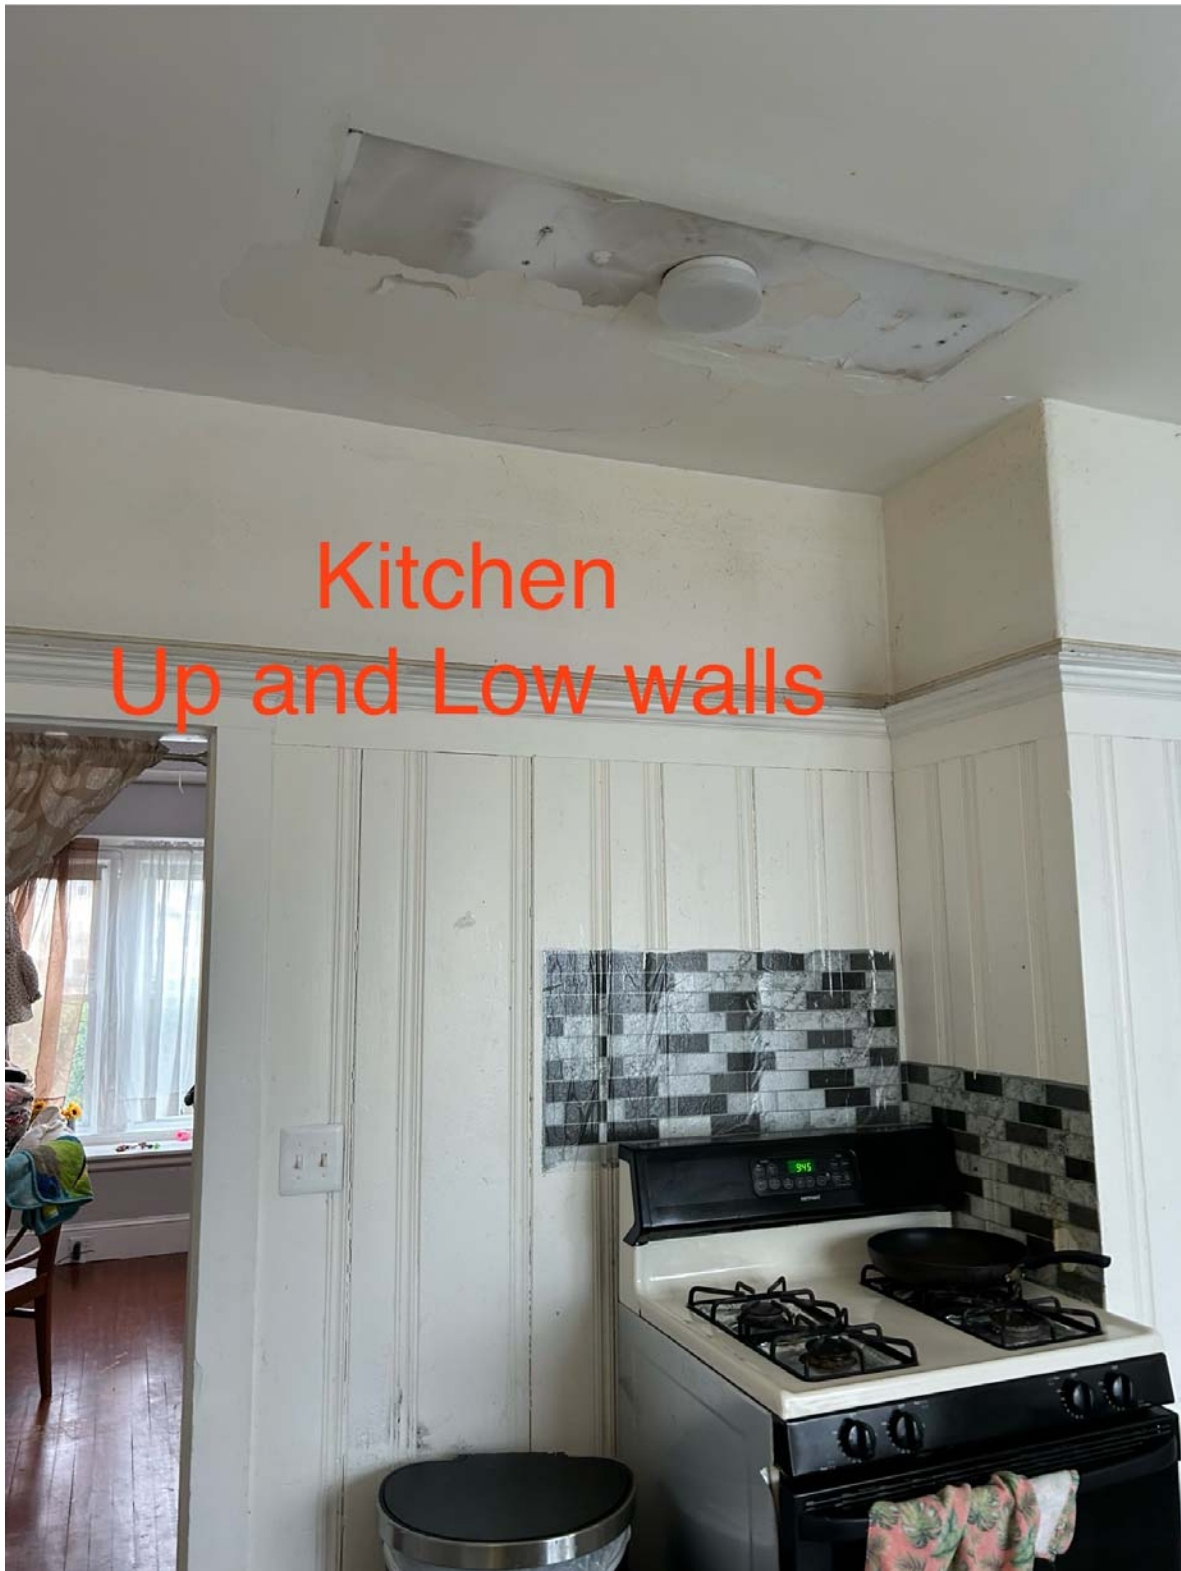
Kitchen  
Up and Low walls

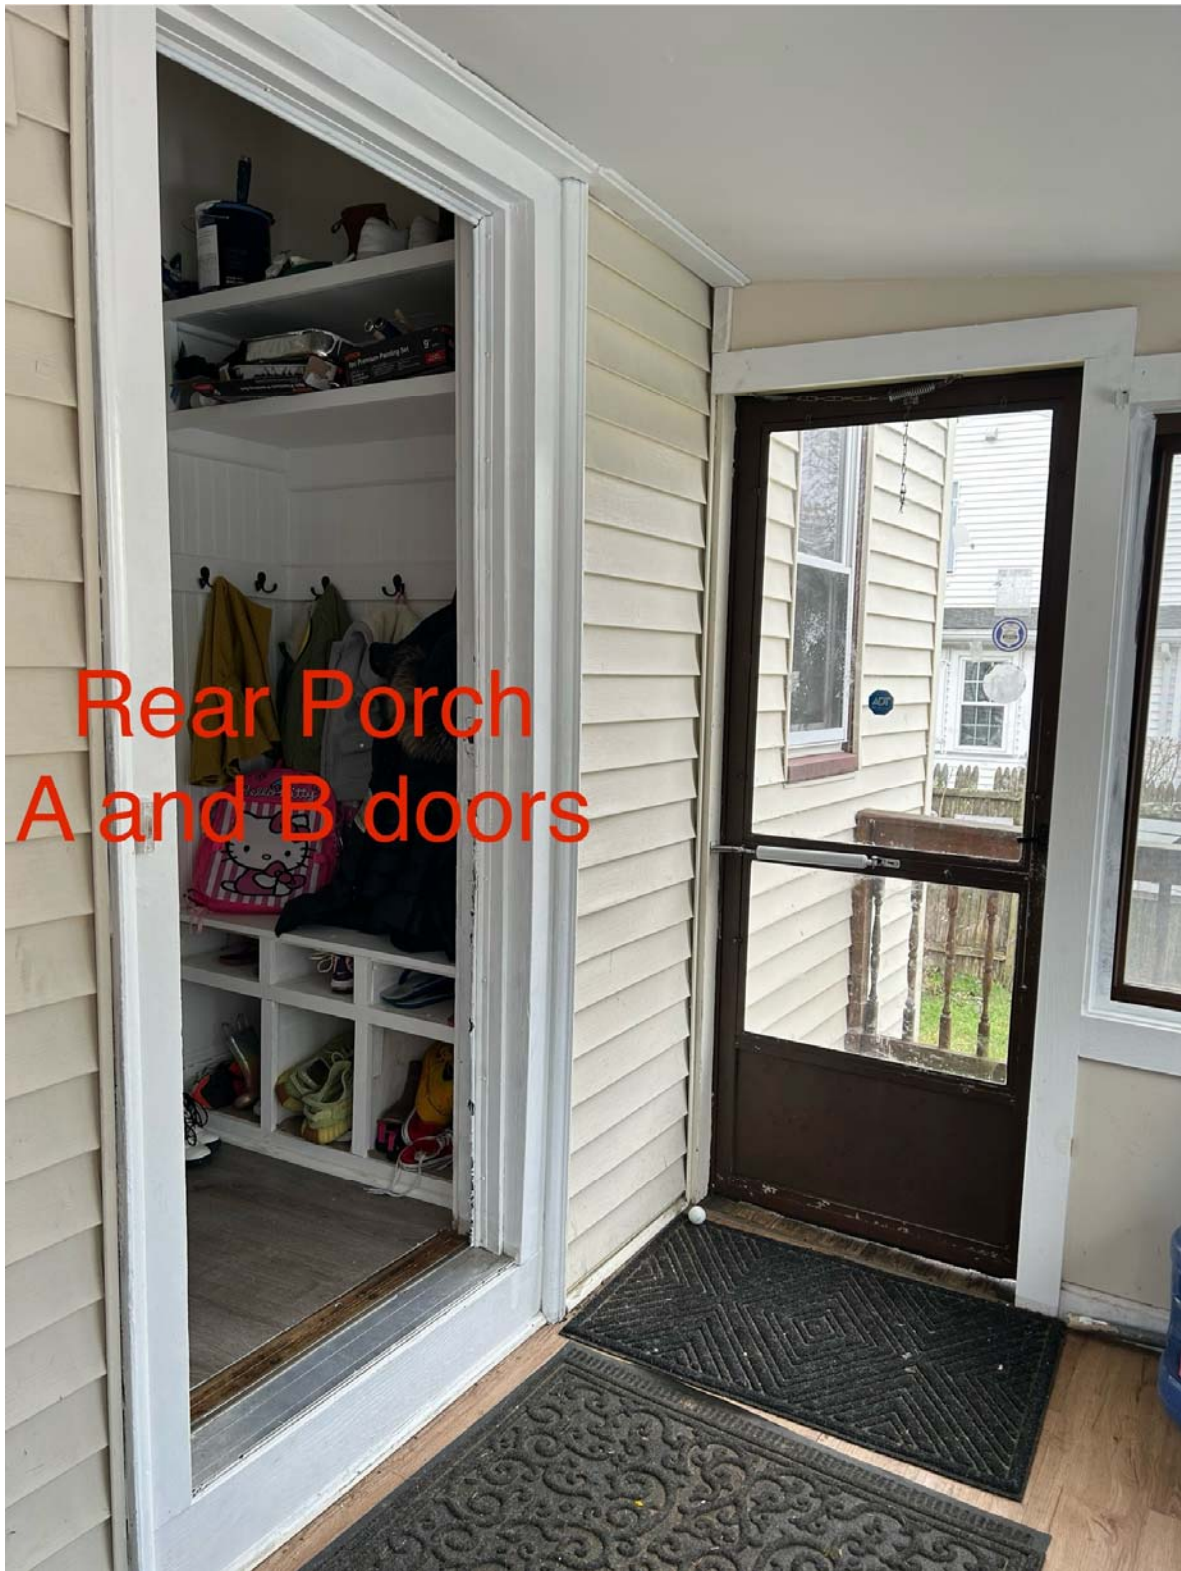
Rear Porch  
A and B doors

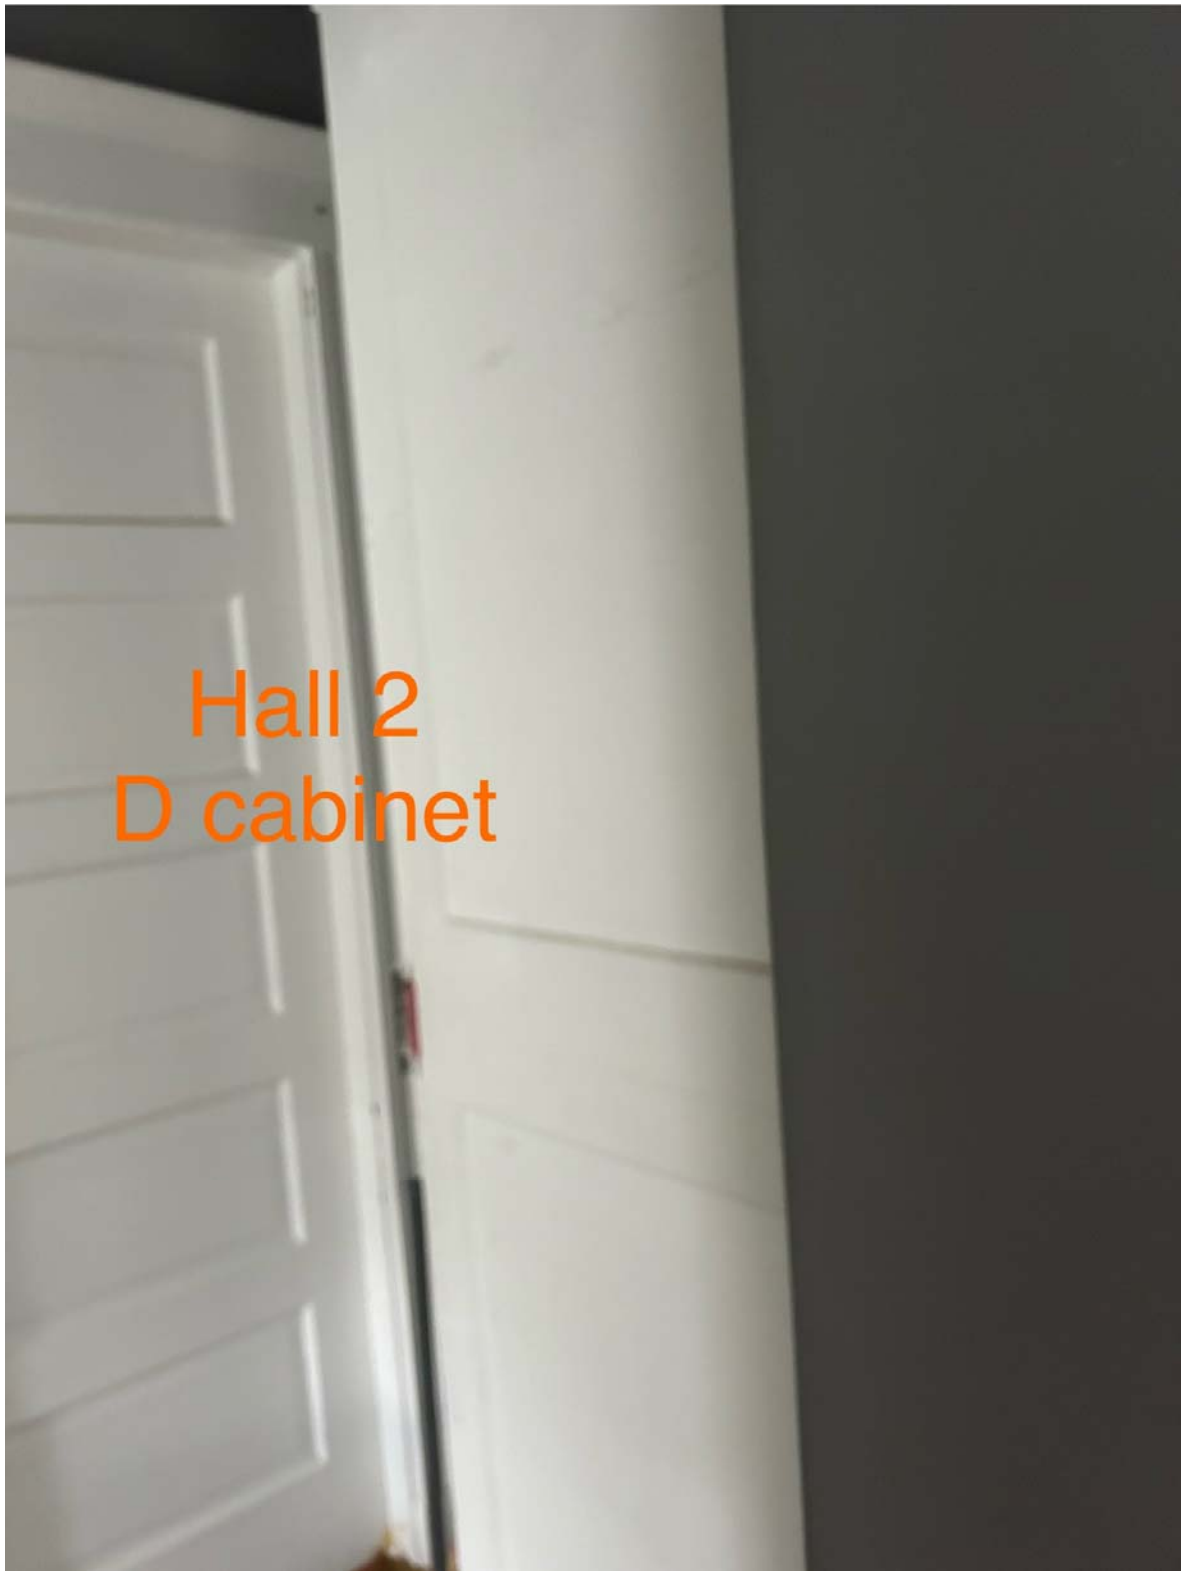
Hall 2  
D cabinet

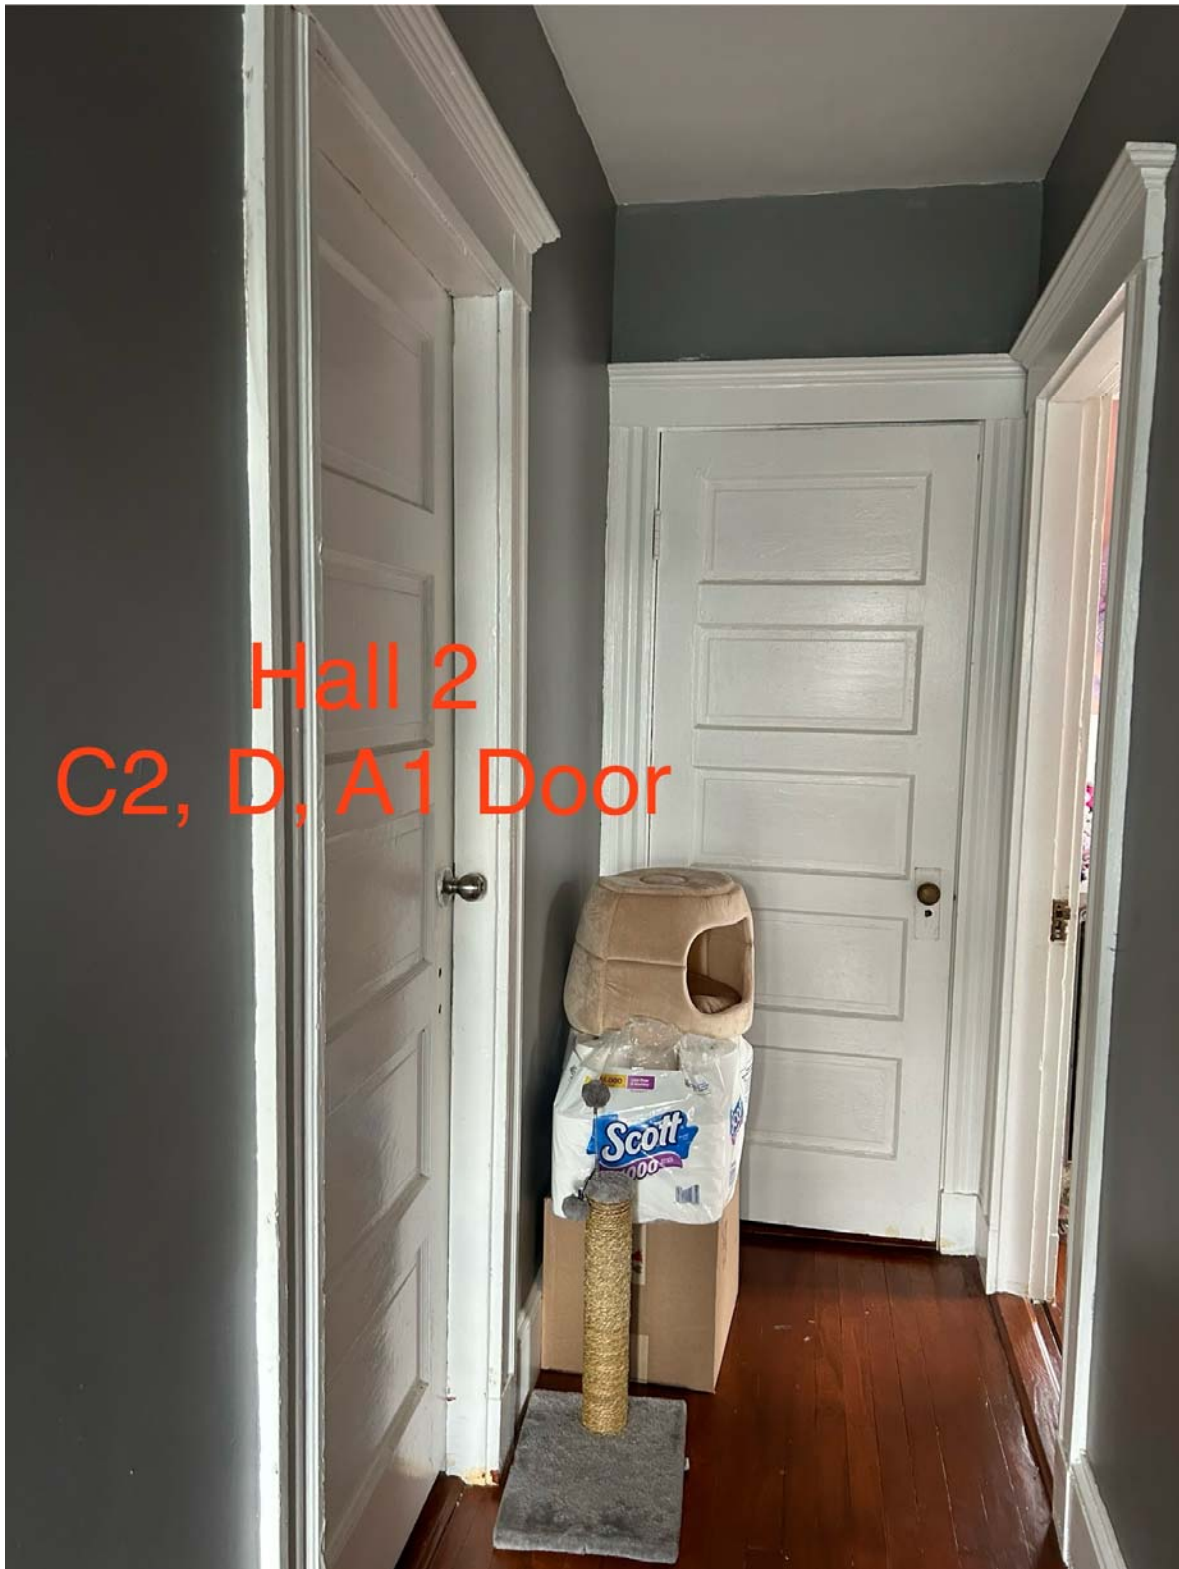
Hall 2  
C2, D, A1 Door

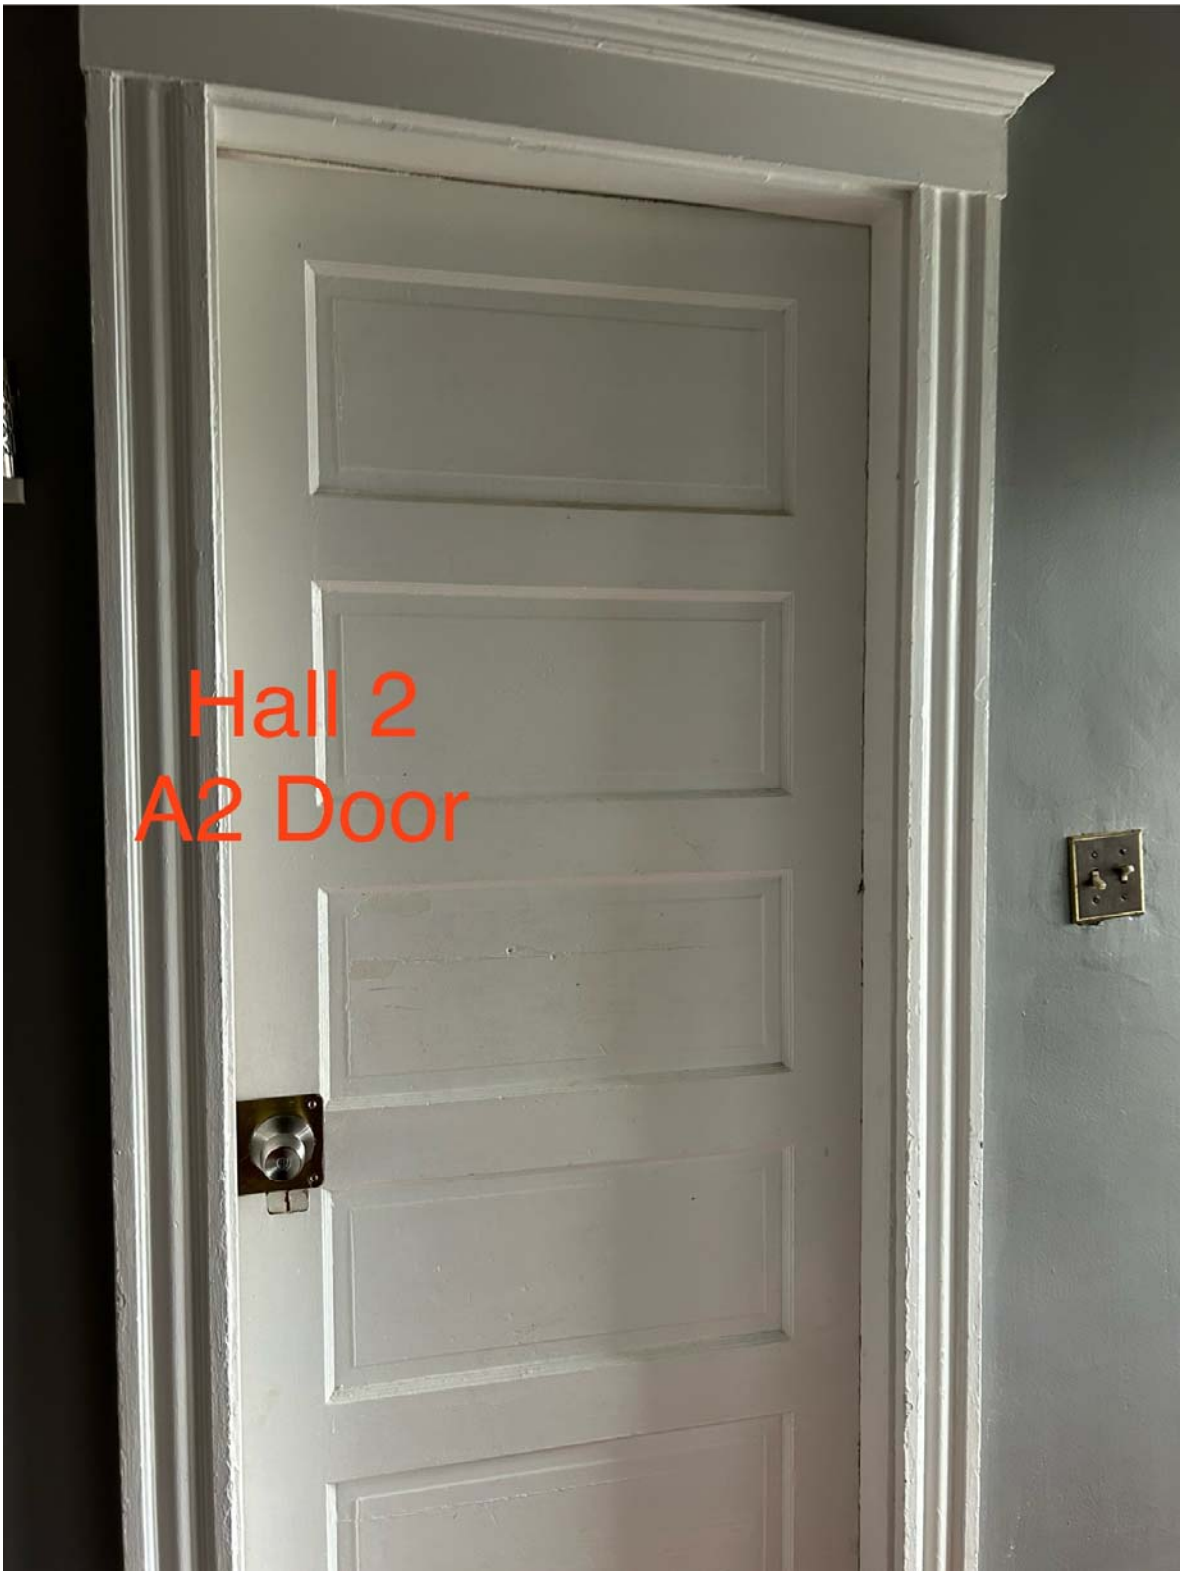
Hall 2  
A2 Door

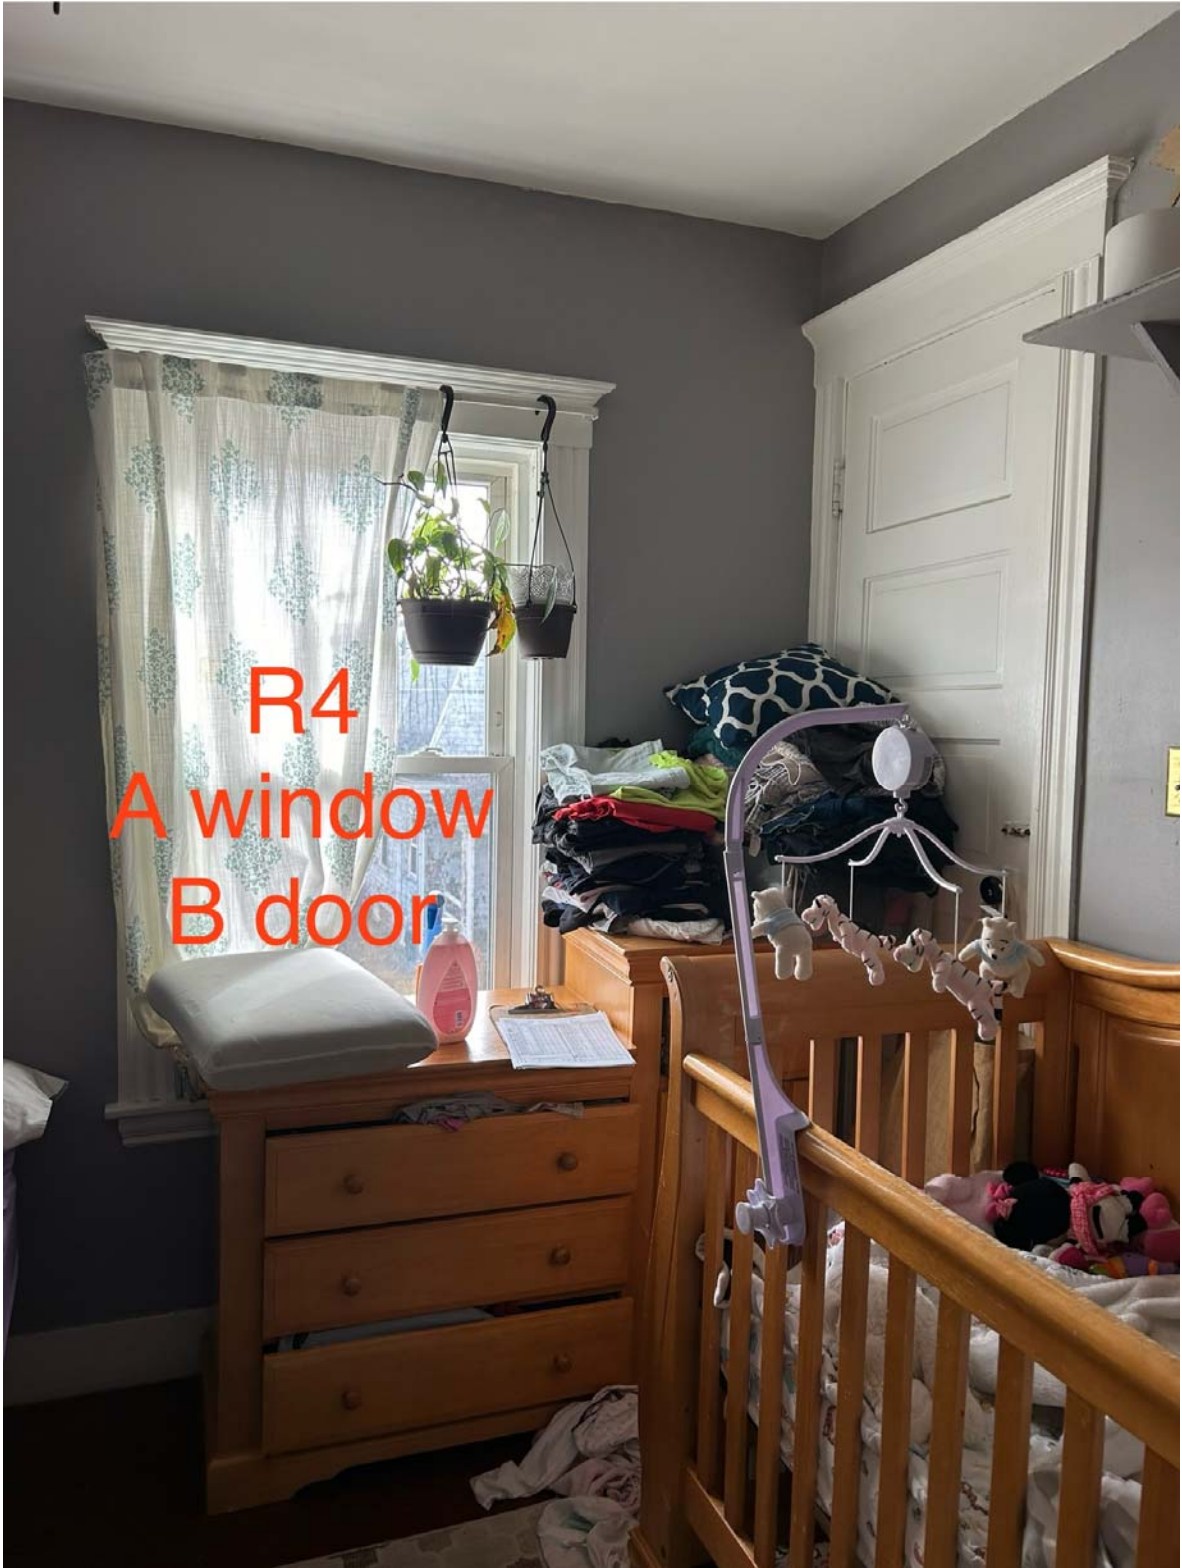
R4  
A window  
B door

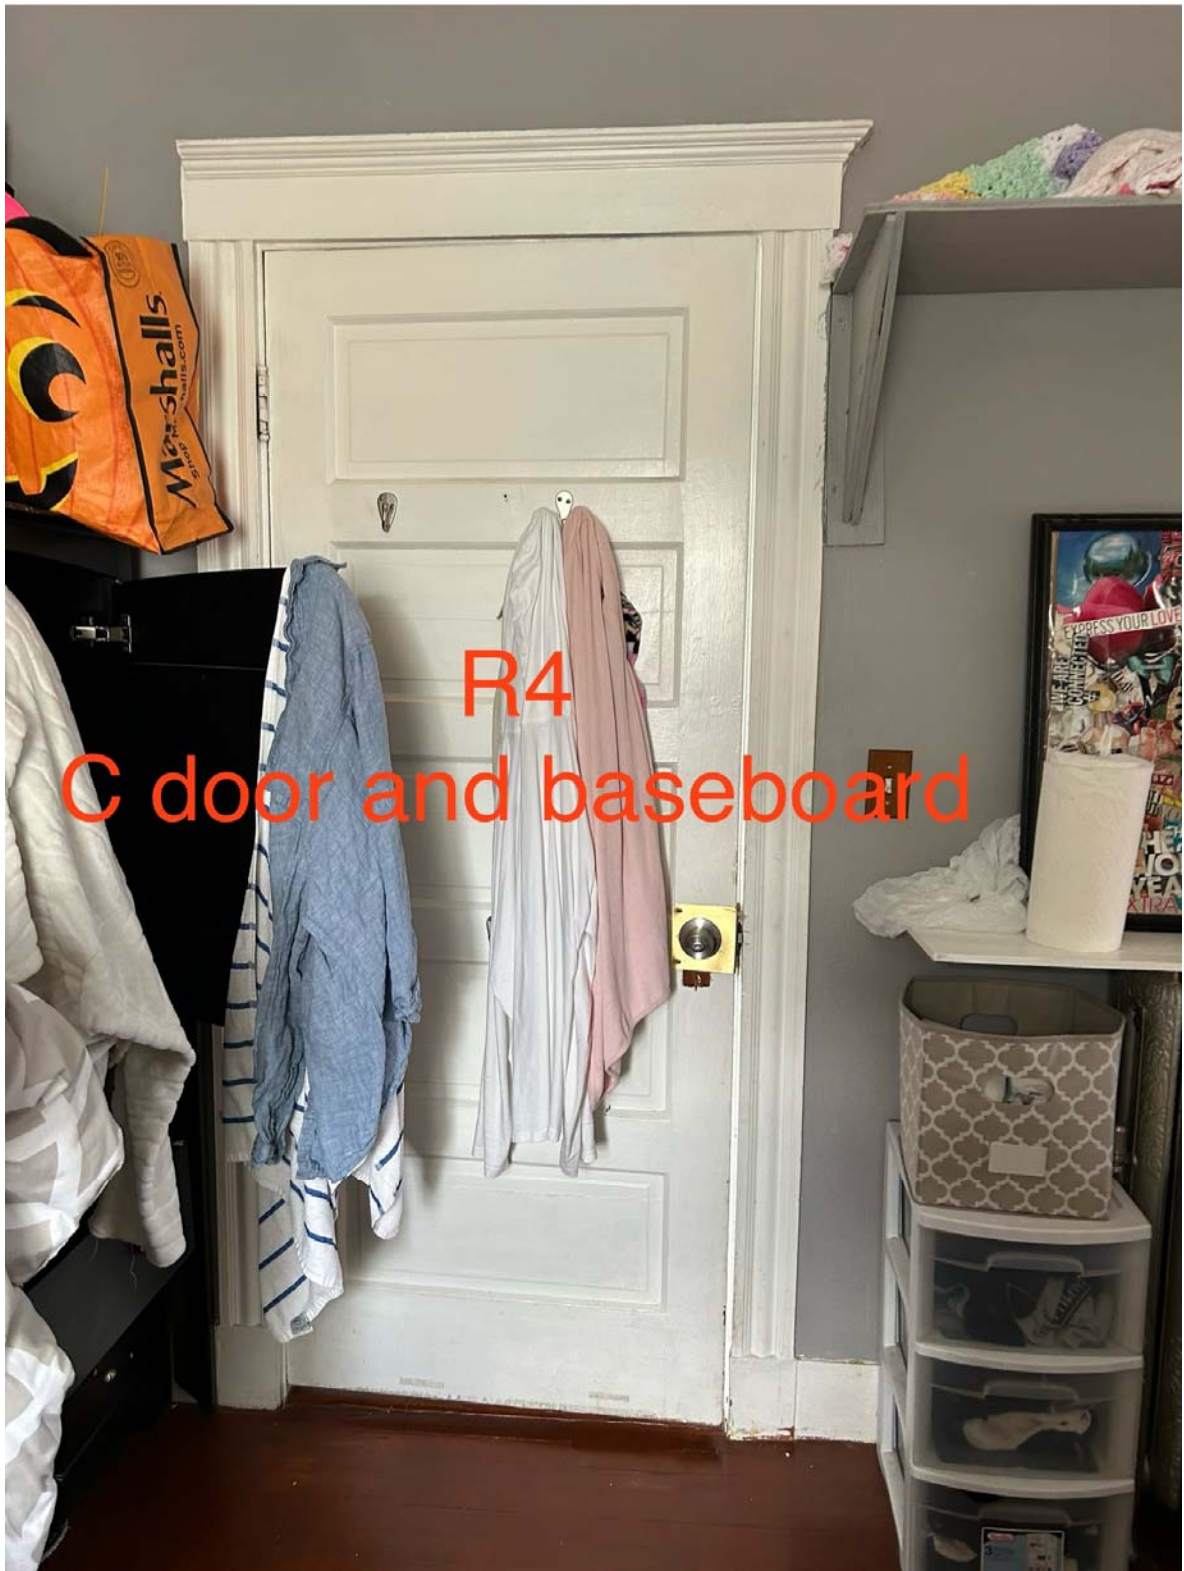
R4  
C door and baseboard

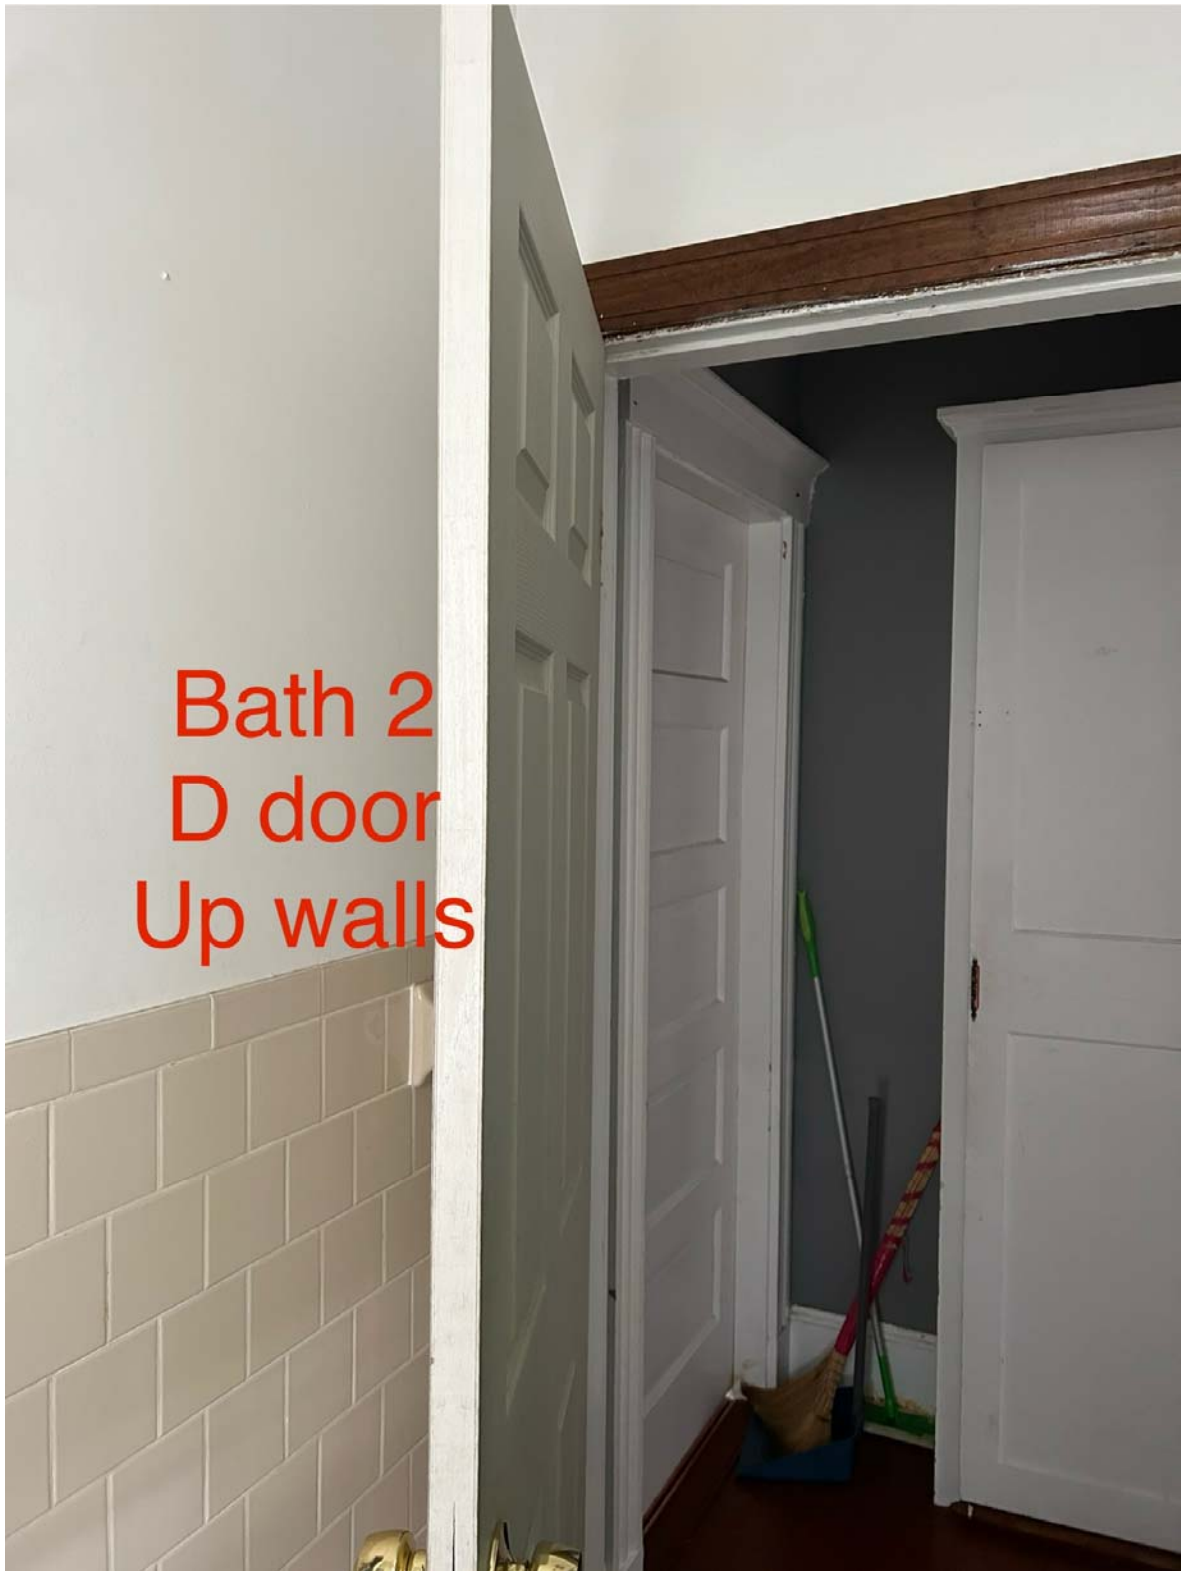
Bath 2  
D door  
Up walls

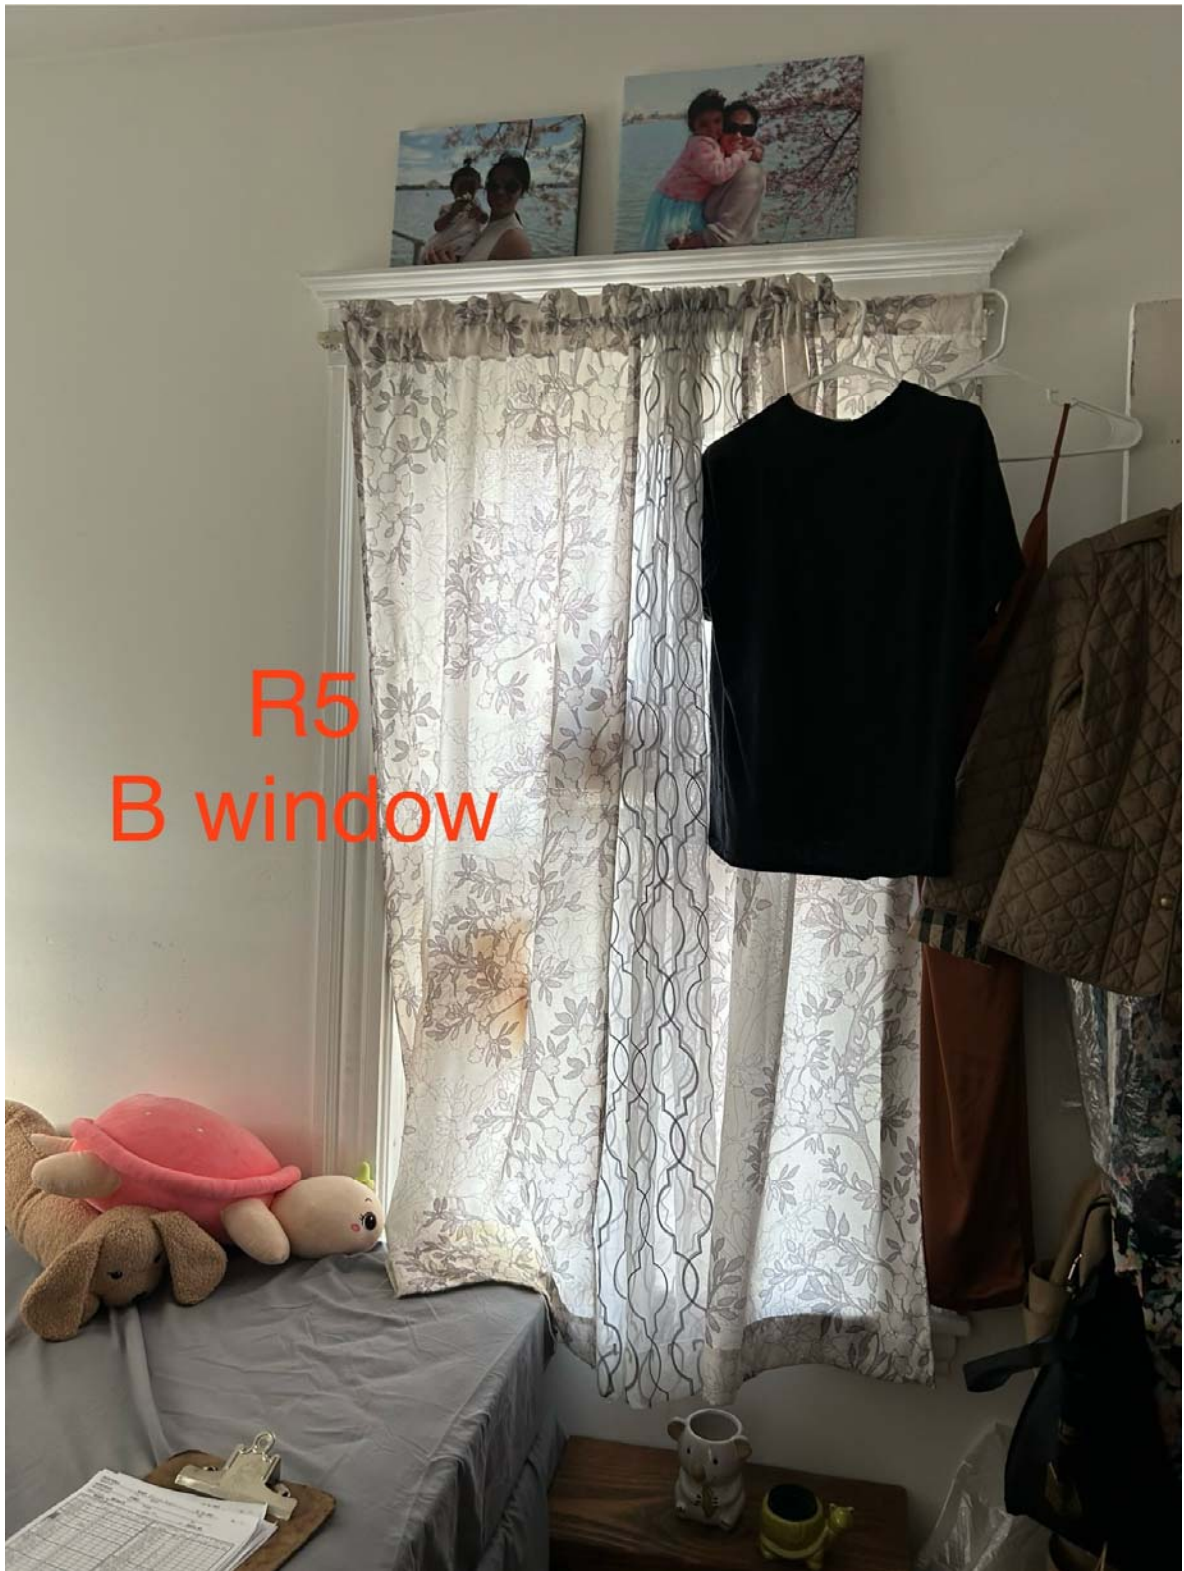
R5  
B window

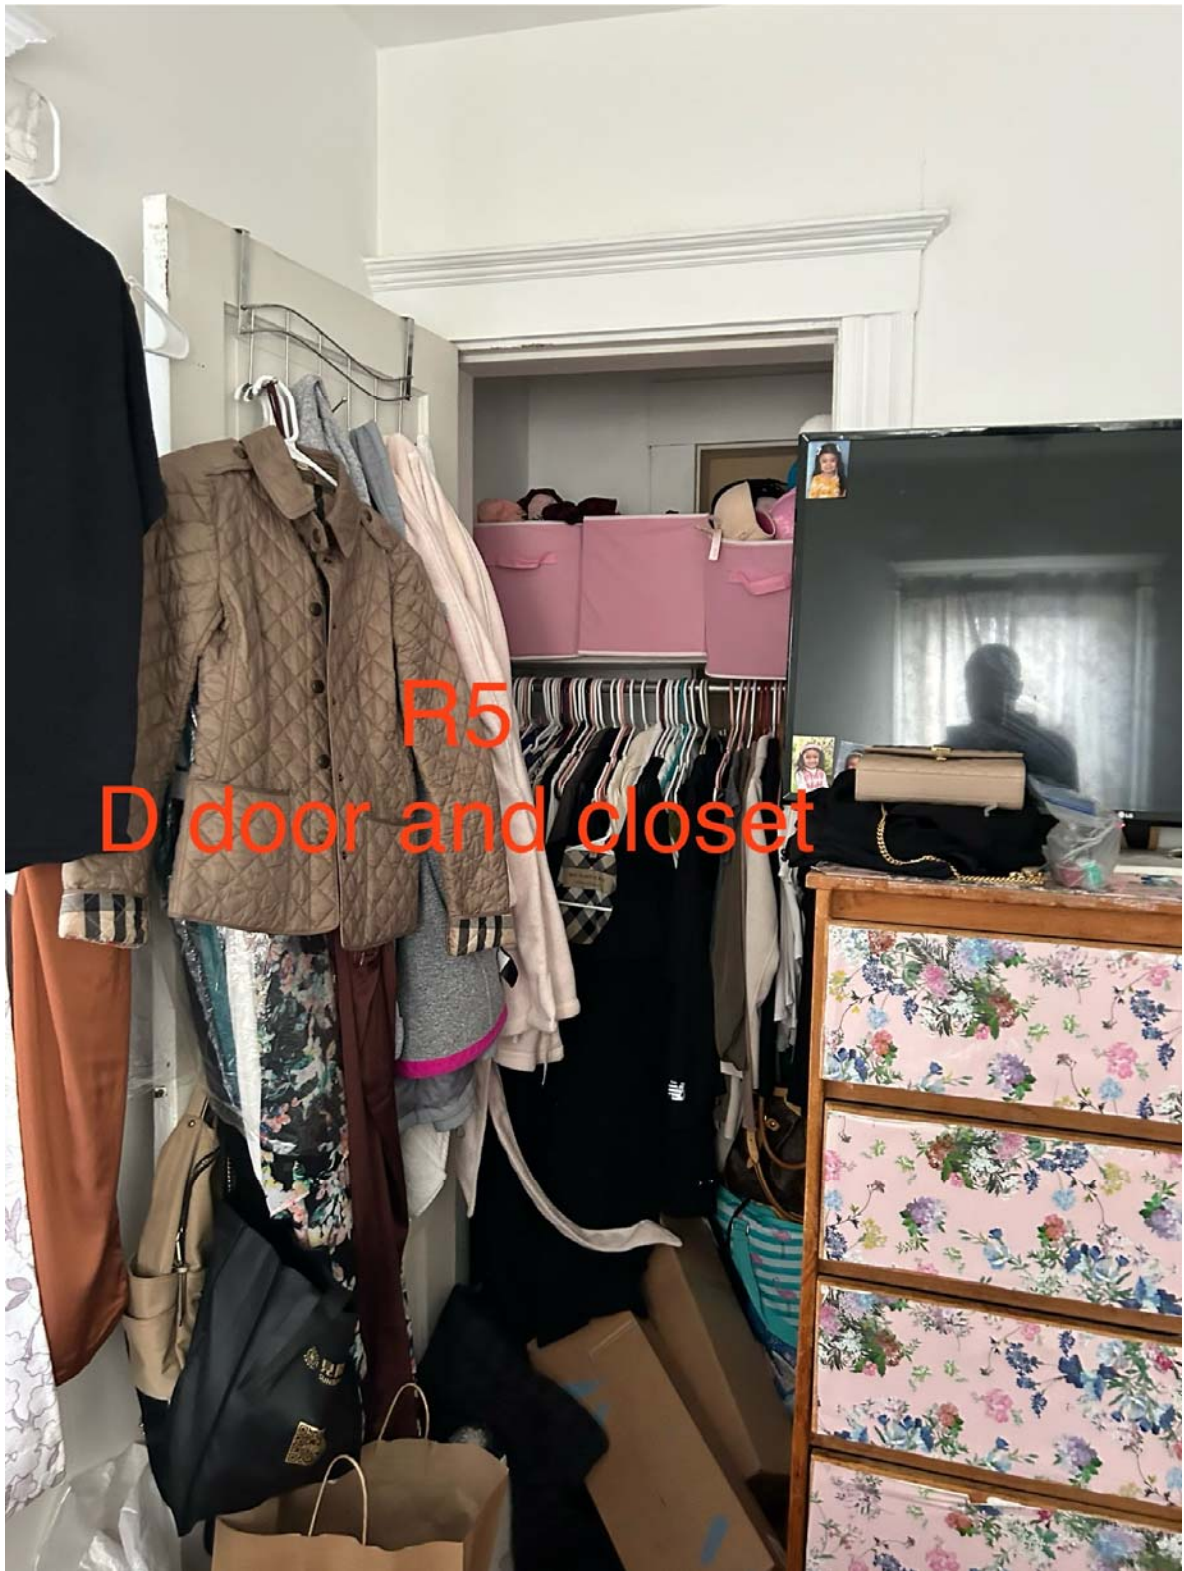
R5  
D door and closet

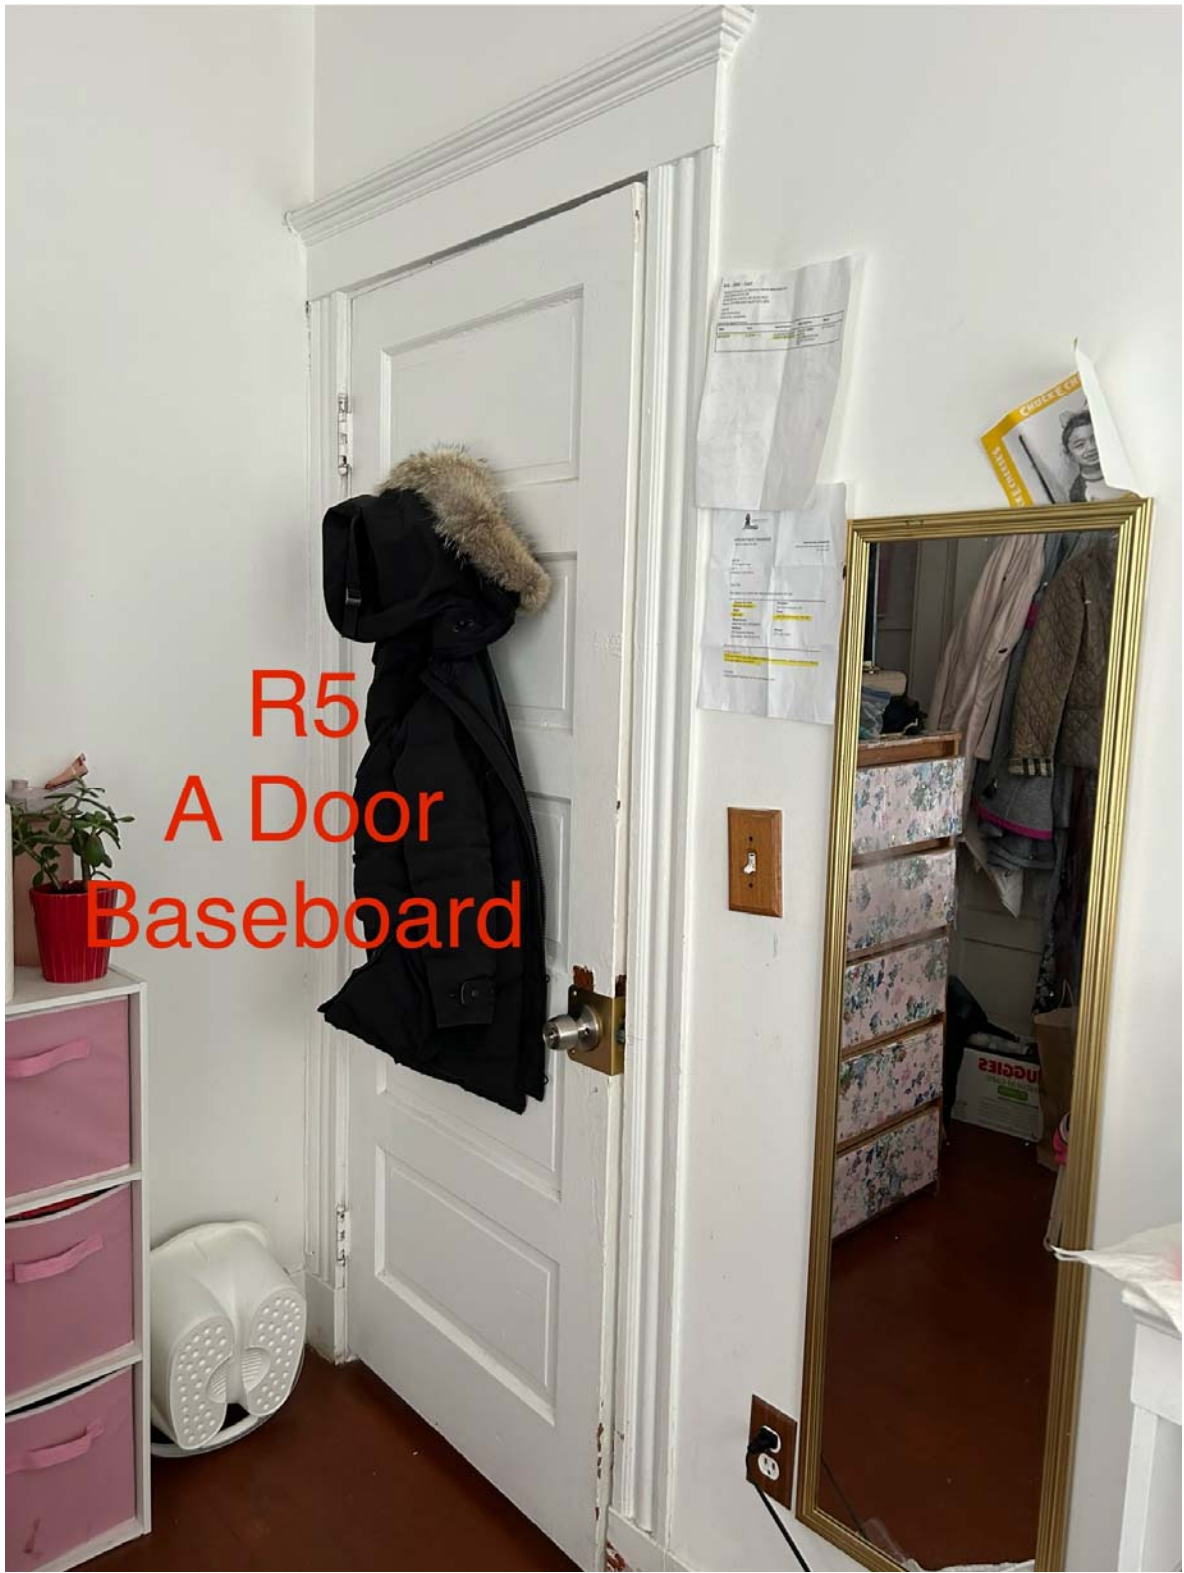
R5  
A Door  
Baseboard
