# Lead-Based Paint Testing and Lead Hazard Risk Assessment Report

PERFORMED AT:  
465 Beale St.  
Quincy, MA 02169

PREPARED BY:  
Titan Lead Testing, LLC  
MA License # MI/R 4025  
Expires 04/26/2023  
PO Box 760709  
Melrose, MA 02176

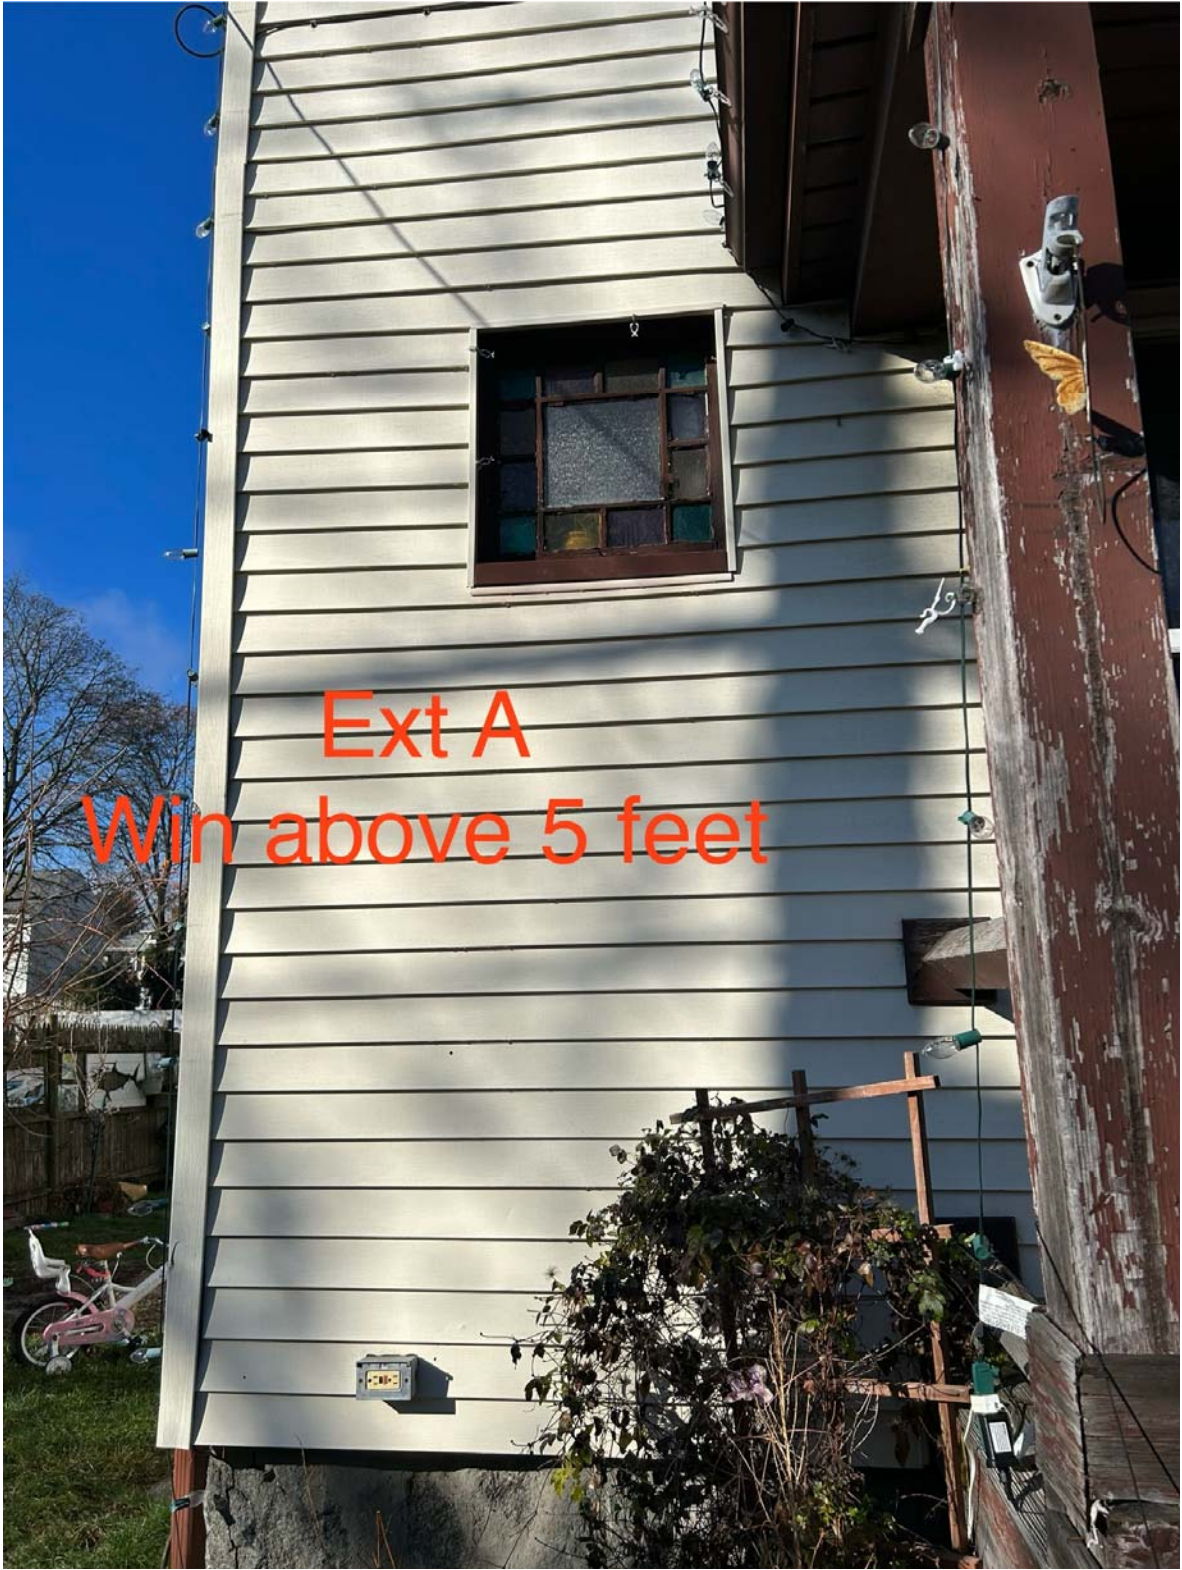
Ext A  
Win above 5 feet

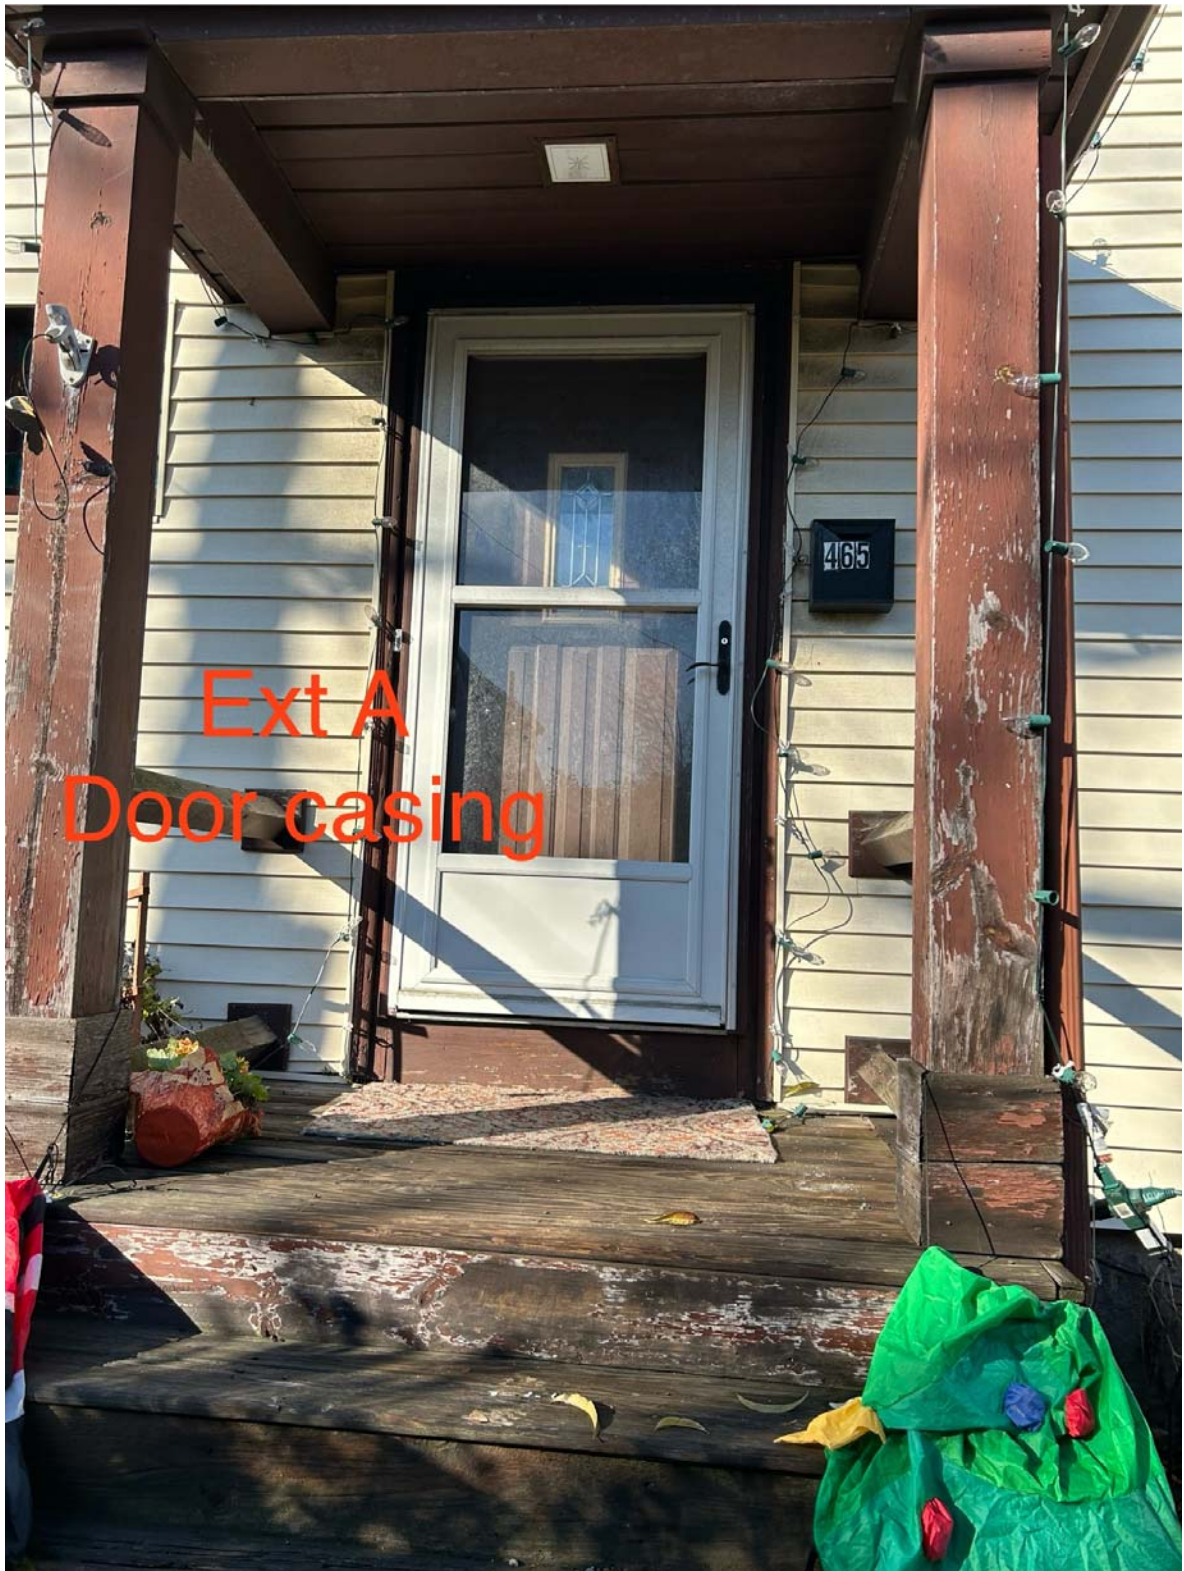
Ext A  
Door casing

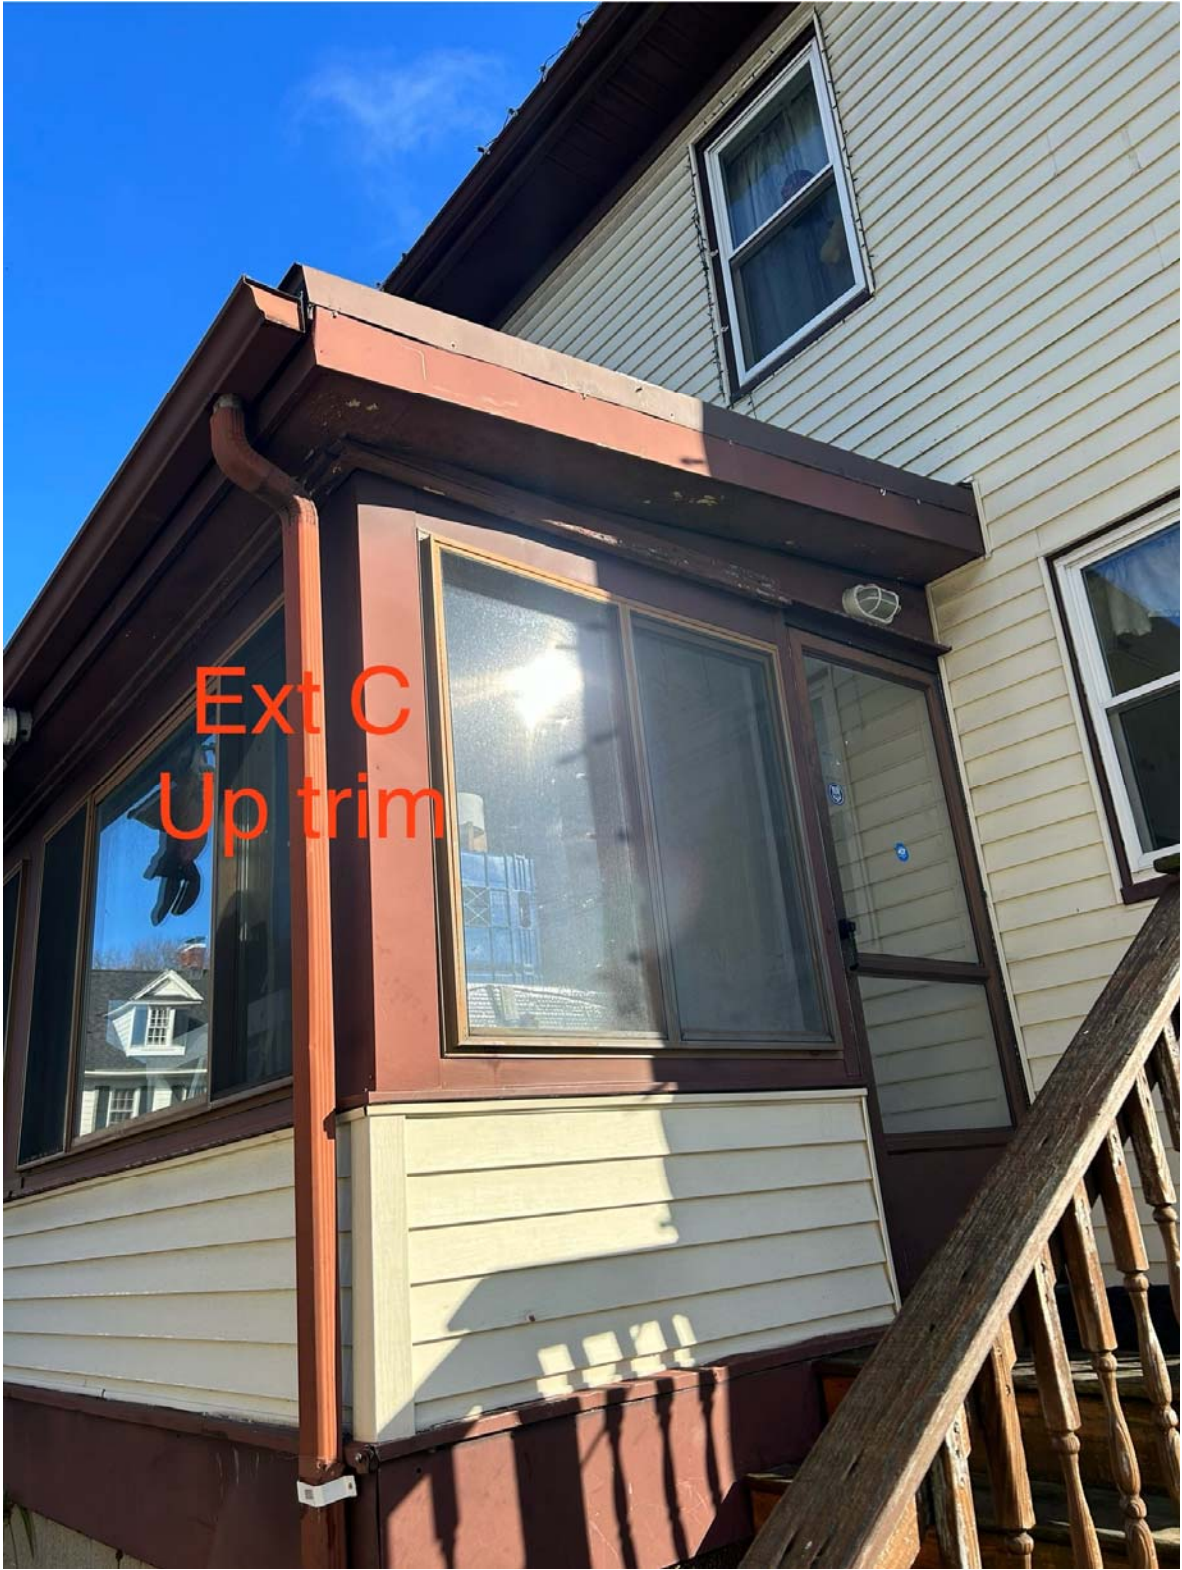
Ext C  
Up trim

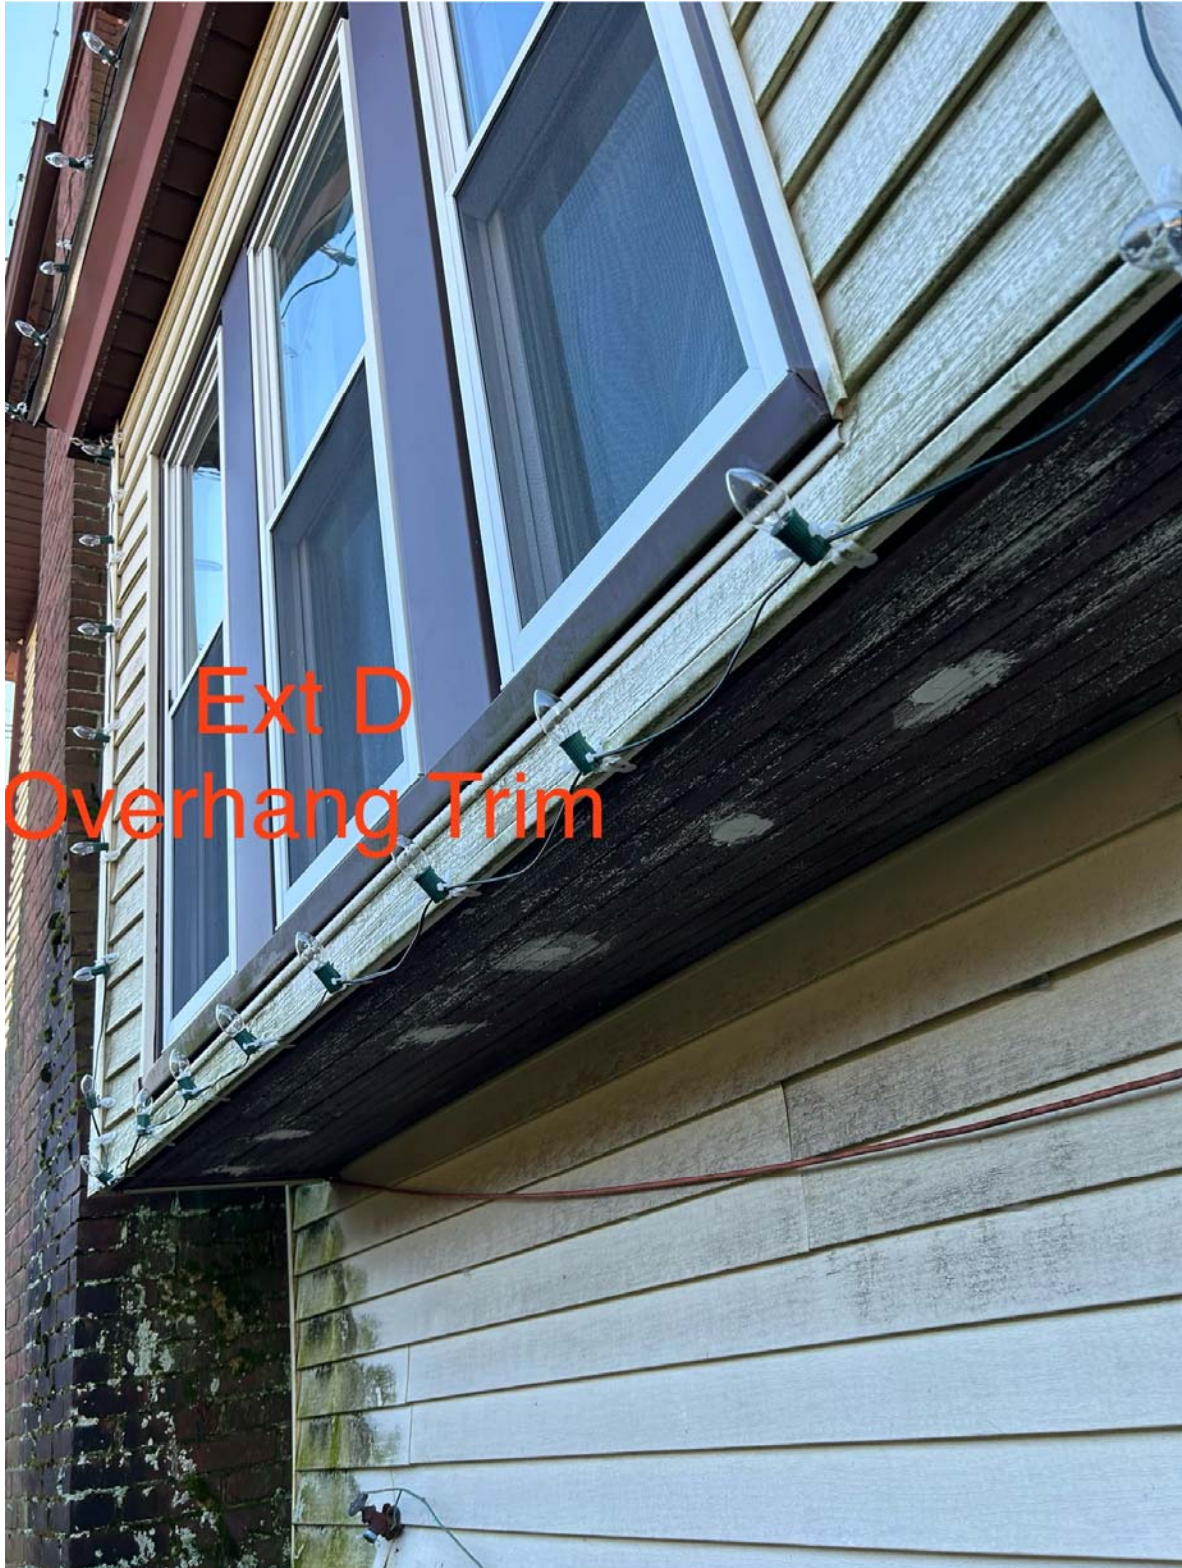
Ext D  
Overhang Trim

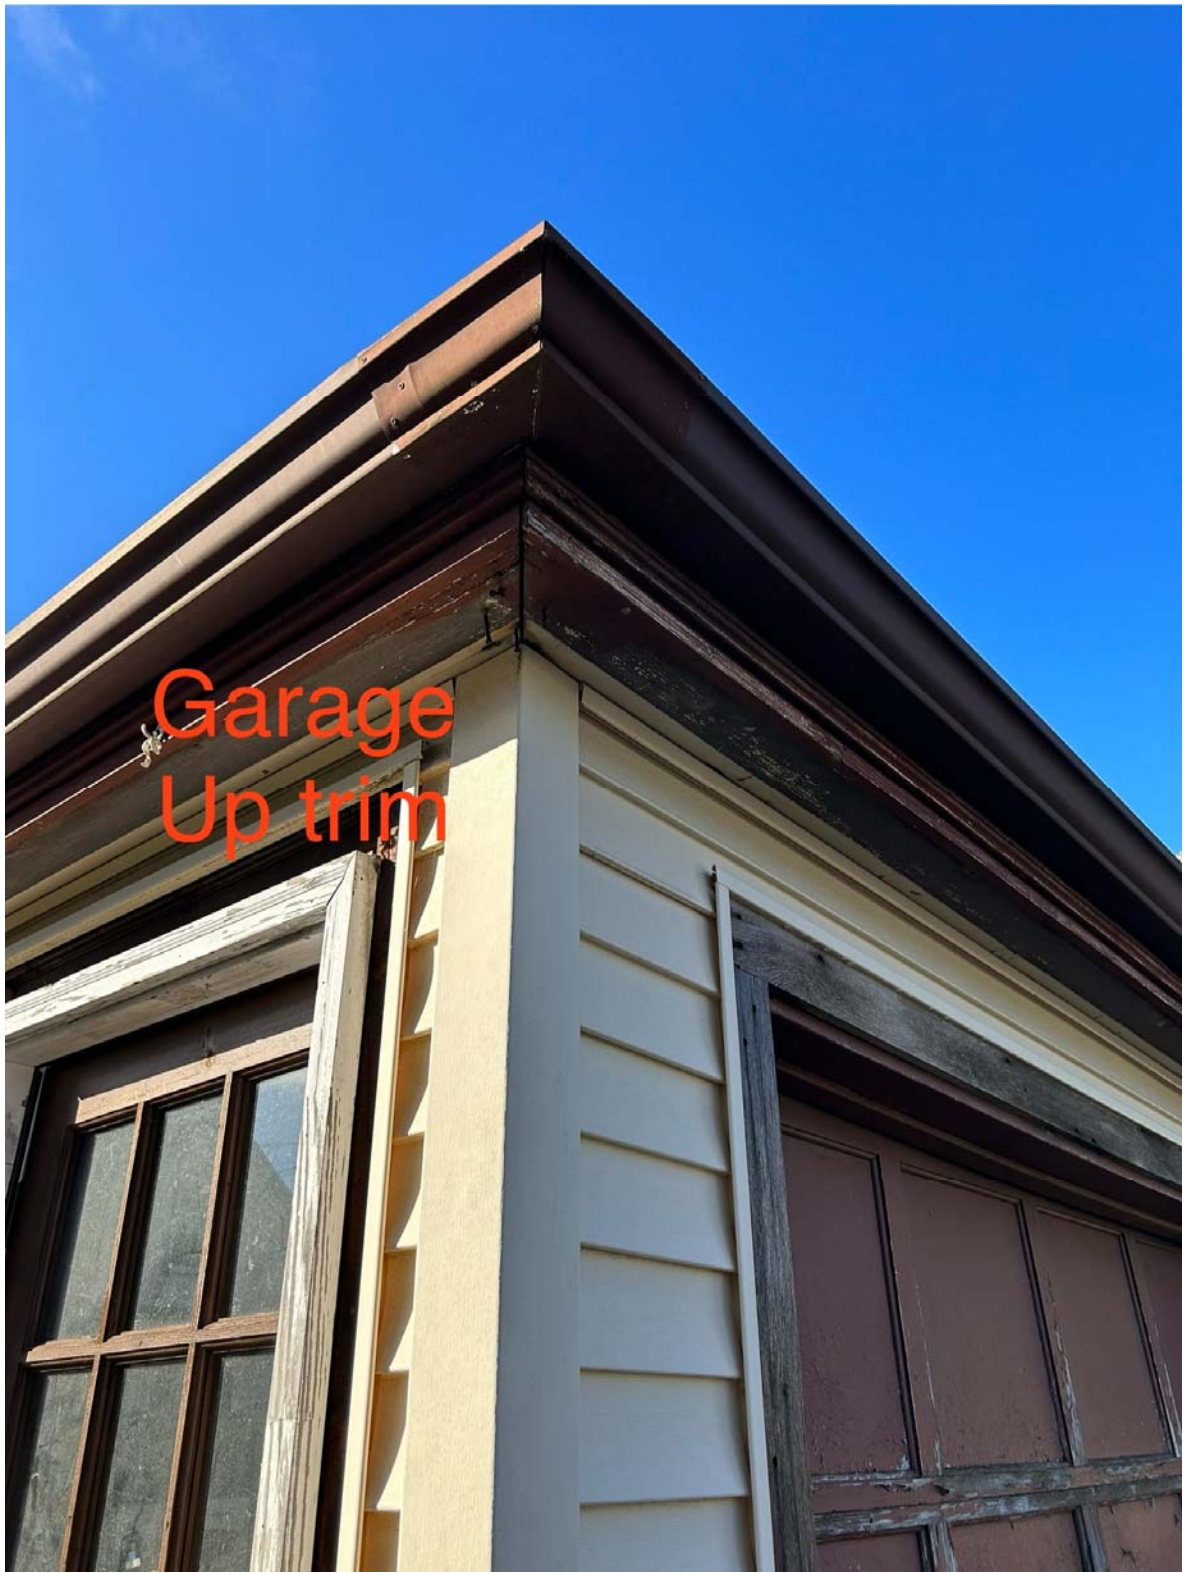
Exterior B Side	B1	Cellar Window Frame	2.8	Deteriorated
Exterior C Side	C	Upper Trim	13.1	Deteriorated
Exterior D Side	D	Overhang Trim	12.0	Deteriorated
Garage	A	Upper Trim	6.9	Deteriorated
Garage	B	Upper Trim	7.3	Deteriorated
Garage	C	Upper Trim	6.4	Deteriorated
Garage	D	Upper Trim	7.2	Deteriorated

Garage  
Up trim

Garage: Upper trim.	Paint stabilization	<ol style="list-style-type: none"> <li>1. Paint removal</li> <li>2. Removal and replacement</li> <li>3. Covering/encapsulation*</li> </ol>
